# **SUNKEN CITY LANDSLIDE – PRELIMINARY FEASIBILITY STUDY**

Task Order Solicitation GEO File No. 15-160  
Point Fermin Park Area, San Pedro  
Los Angeles, California

December 23, 2016

Project No. IR16166090

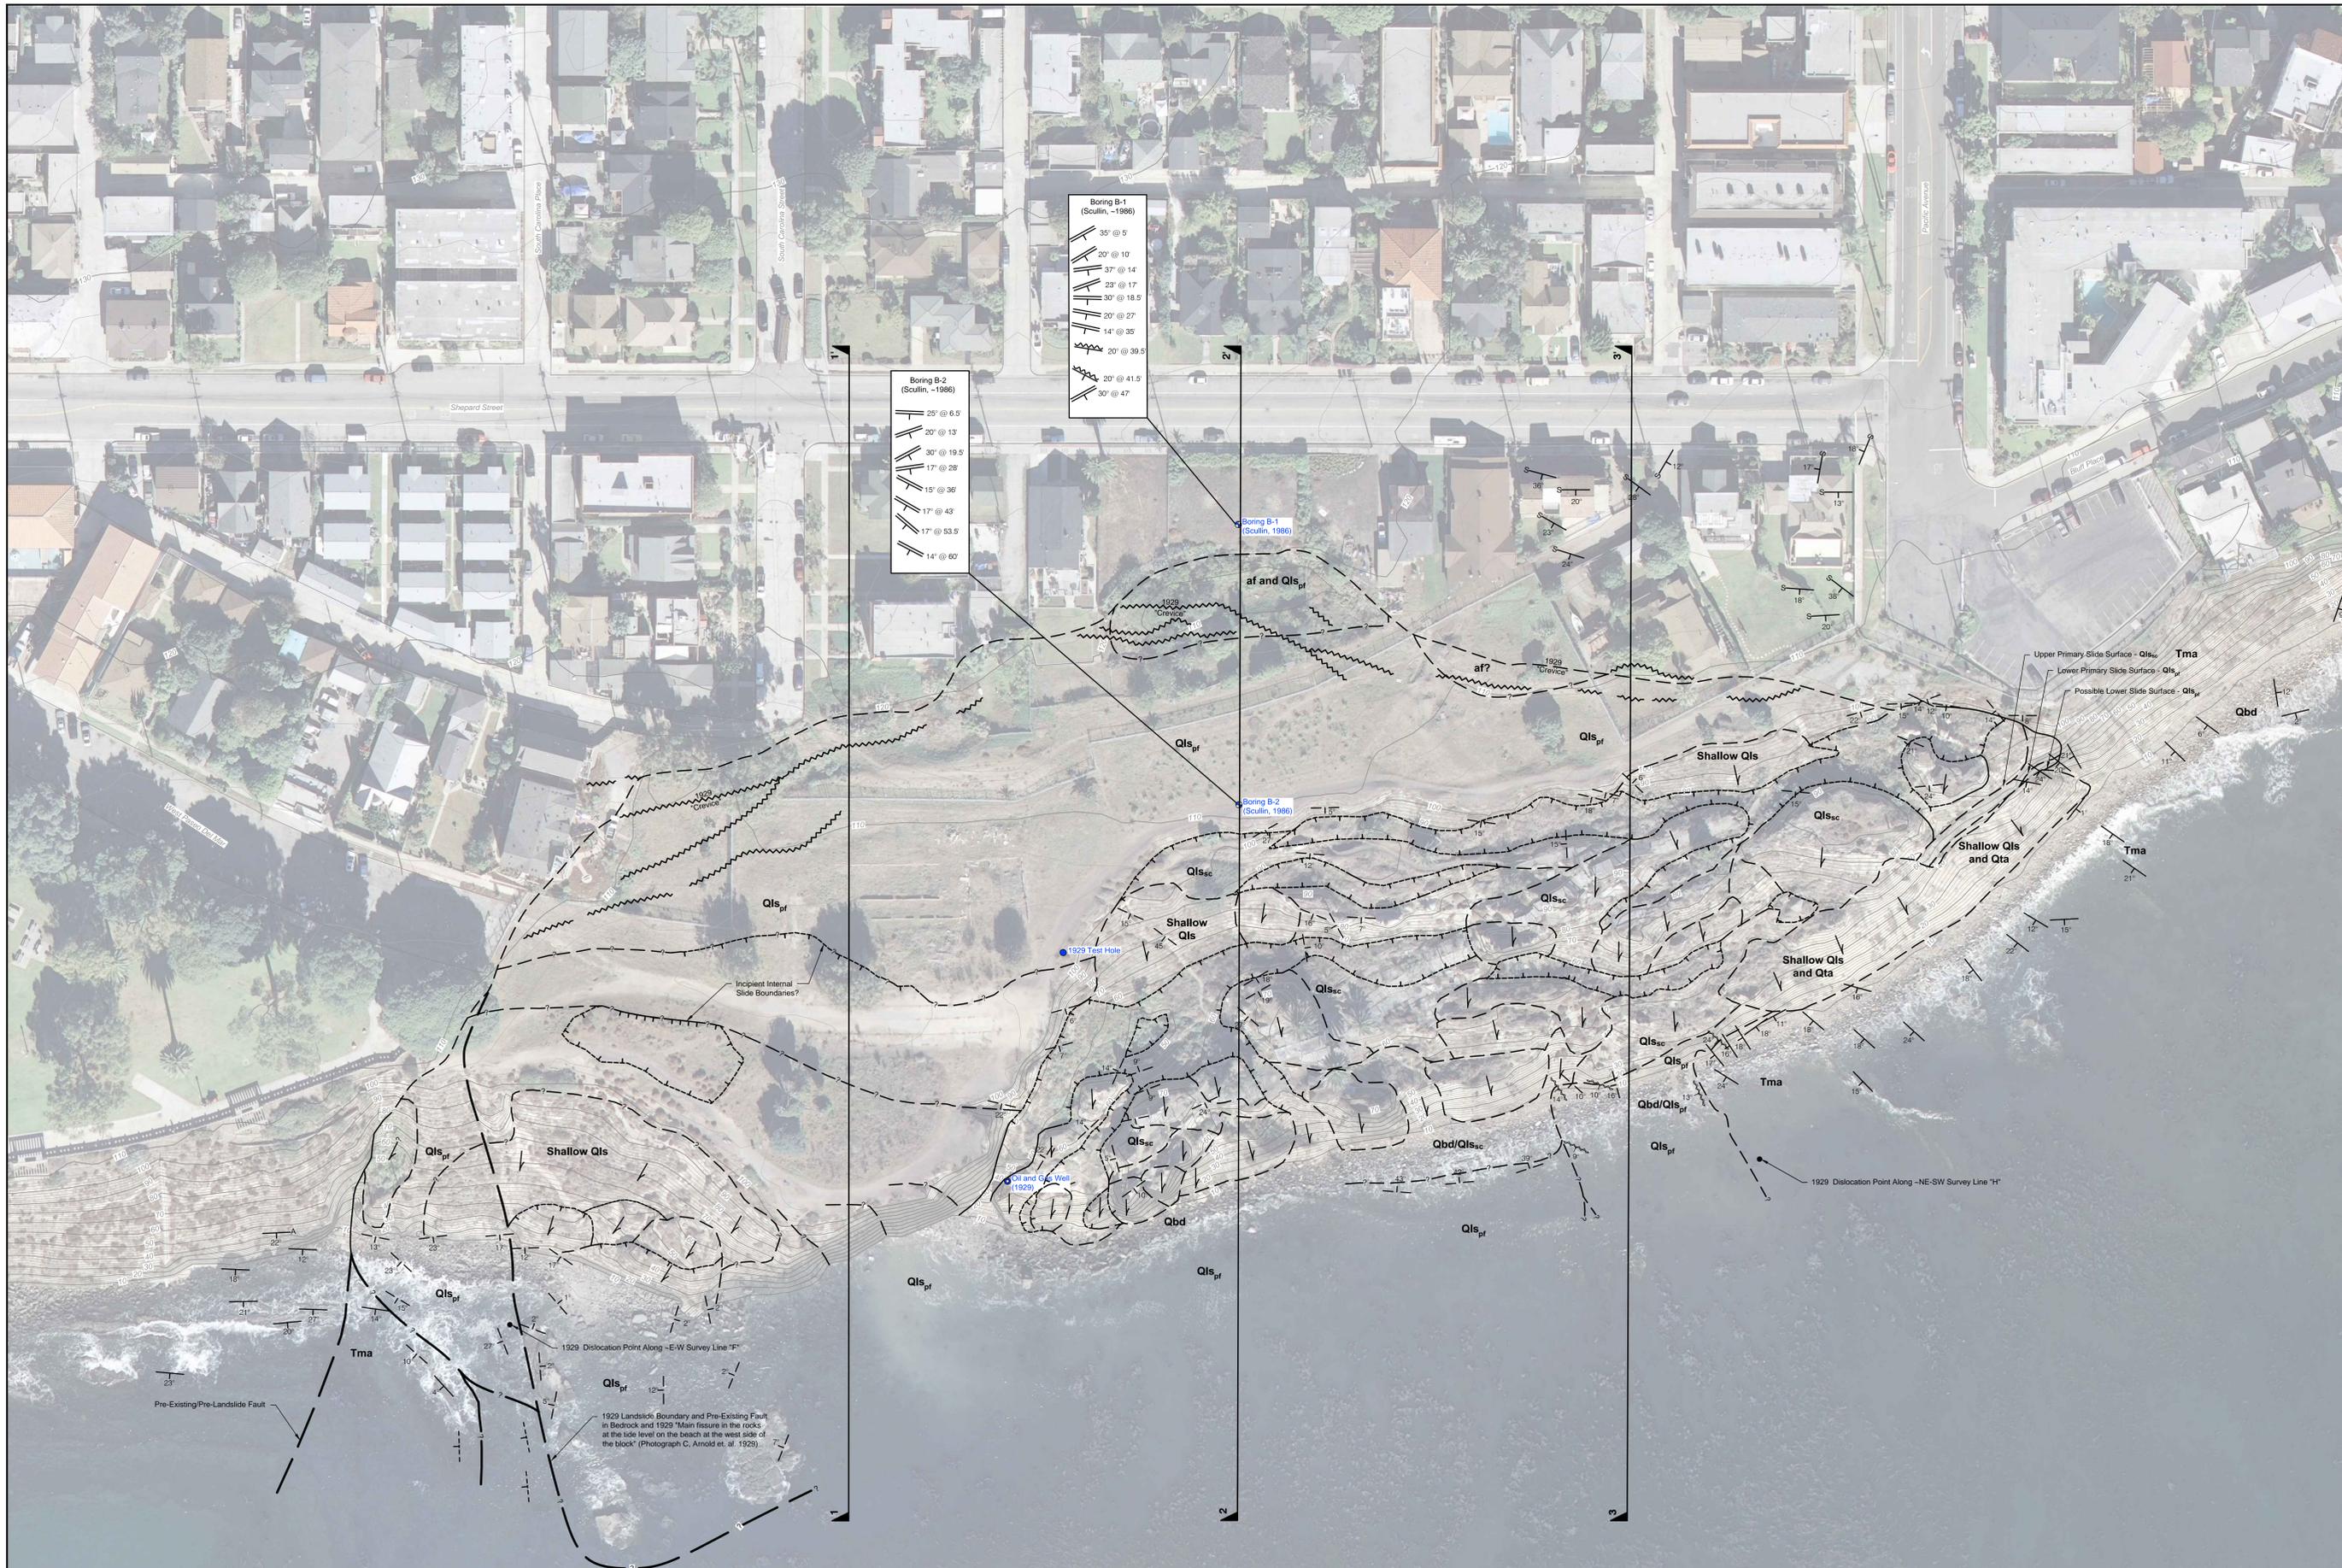
Date: December 2016	Project No. IR16166090	Plate
Submitted By: stk	Drawn By: pah	<b>1</b>

The original ground surface in the Point Fermin landslide area was an essentially level terrace with a slight seaward slope, similar to what exists in the adjoining Pt. Fermin Park area to the west. Displacement of the landslide originally occurred as a relatively coherent block or rock mass that moved seaward along weak strata/bedding in the underlying bedrock that are tilted towards the ocean (this is known as a translational landslide). Cracks and what were locally described as "crevices" developed around the edges of the block as the rock mass moved seaward. Most of the original terrace surface was preserved, but at a lower elevation and at a location that is about 20 to 25 feet further seaward (the ratio of the maximum horizontal and vertical displacements measured in the 1929 through 1941 survey monitoring is consistent with an overall seaward inclination of the underlying bedrock strata of about 18 to 22 degrees). The current ground surface of the greater Point Fermin landslide is somewhat undulatory, reflecting the presence of broad areas of extension and settlement along incipient slide block boundaries (Plate 1).

Original displacement along the westerly edge of the Point Fermin landslide appears to have occurred along a pre-existing fault in the bedrock that crossed down the face of the bluff and across the adjoining intertidal zone along a trend that is slightly east of due-south (Plate 1). The westerly edge of the landslide in Arnold’s 1929 geologic report is described as a fissure where it crosses the intertidal zone, and his report includes a picture of a large group of men reviewing the fissure in the beach area (Appendix D). Descriptions in 1929 and comparison with the current exposures suggest that several feet of uplift has occurred through time on the easterly side of that fissure. 1929 survey measurements along a line parallel to the shoreline also identified the apparent offshore edge of landsliding, which coincides with this fault feature in the intertidal zone (refer to “dislocation point” along Survey Line “F” on Plate 1).

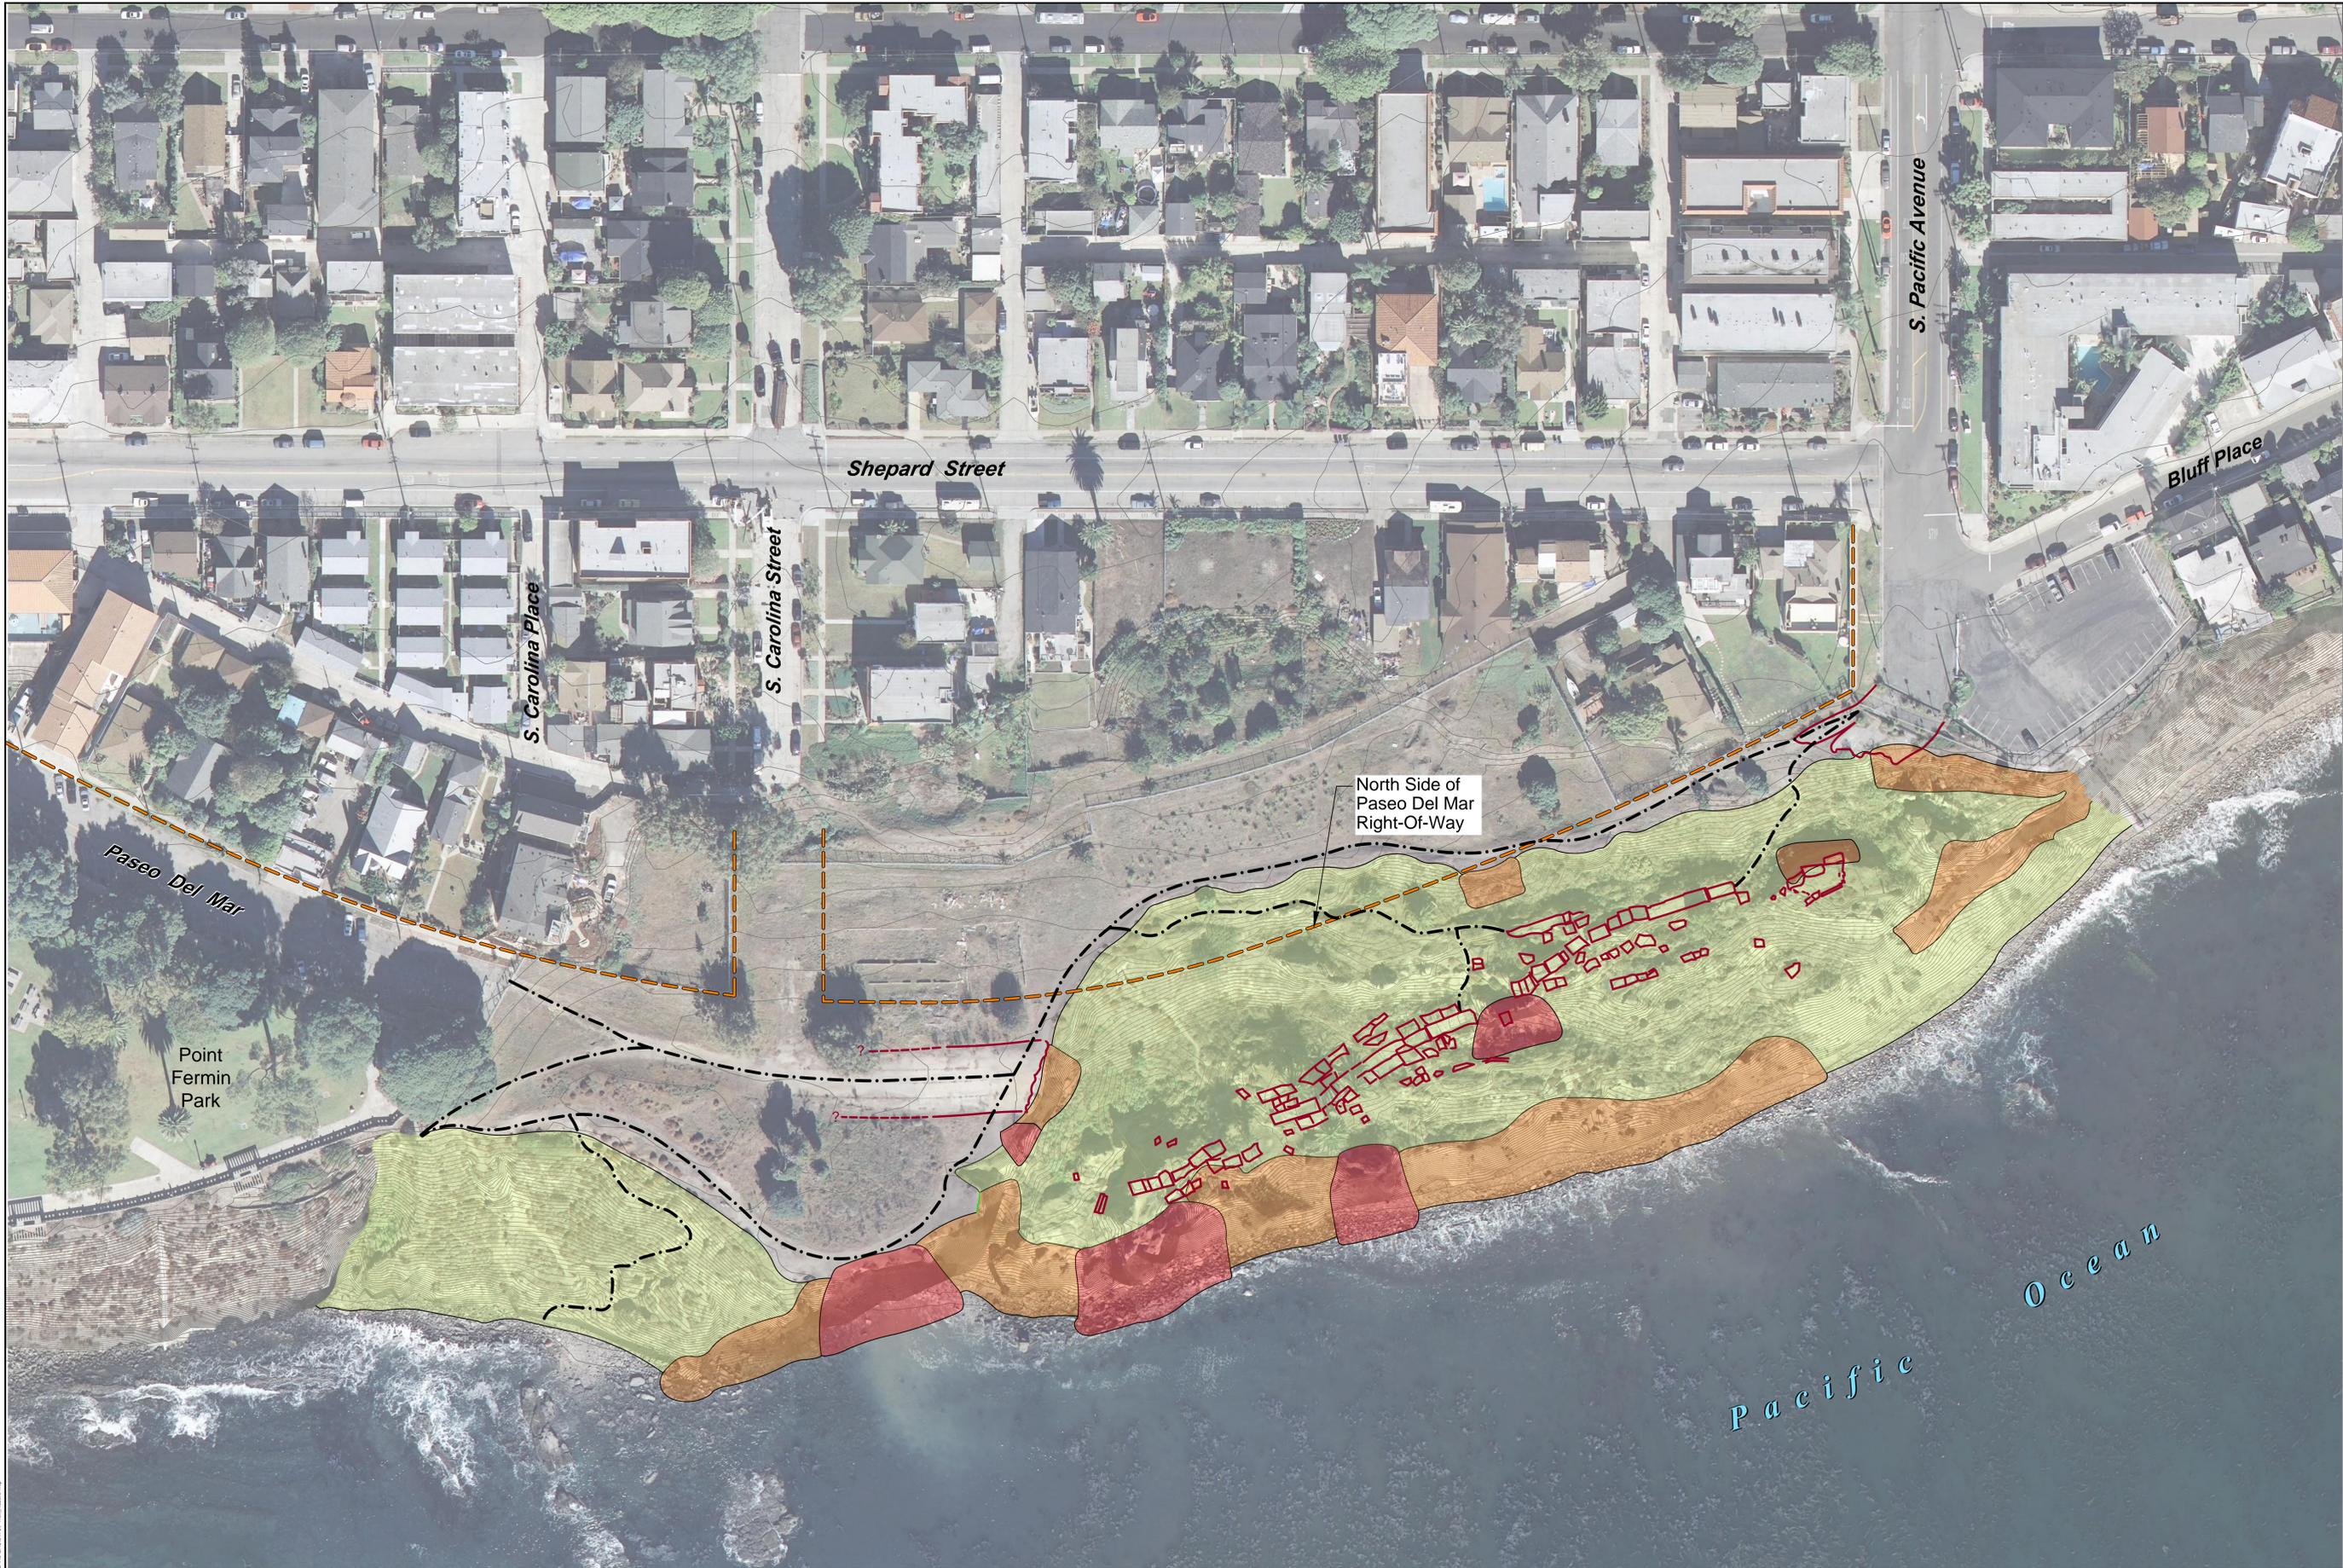
**POINT FERMIN LANDSLIDE AREA - GROUND FAILURE HAZARD ZONES**

“Extreme Hazard” zones were identified by the presence of pervasive dilated fracturing within the bedrock comprising relatively high, very steep slopes/cliffs. Locally extensive open fracture systems have developed in the area as a consequence of continuing long-term displacement of the landslides, and the associated height and steepness of the slopes/cliffs in the “Extreme Hazard” zone area produces a potential for life-threatening catastrophic failure that could occur at any time. These catastrophic failures would affect both the area above/behind the slope, and also to a much more dangerous degree, the area below the slope. Relatively minor rockfalls in these areas could have life-threatening consequences, and are most likely to occur along the ocean shoreline, which is affected by essentially continuous wave erosion. Waves and ocean tides also typically restrict access along the shoreline to a relatively narrow zone along the base of the cliffs, within the influence of even minor rockfalls.

As shown on Plate 3, most of the “Extreme Hazard” zones are located along the shoreline near the westerly boundary of the Sunken City landslide where the erosion resistant, blocky sandstone supports relatively high, very steep sea cliffs and local pinnacles of rock bounded by open fractures. A similar pinnacle area is also present away from the shoreline, near the center of the Sunken City landslide. At that location, the near-vertical rock face appears to be leaning slightly seaward, suggesting a potential for catastrophic toppling failure.

“High Hazard” zones were also identified by the presence of pervasive dilated fracturing within bedrock comprising relatively high, steep slopes/cliffs. However, the steepness of the slopes in

these areas tends to be less, and potential ground failure in these areas is more likely to consist of shallow slabs and rockfalls rather than catastrophic failure or toppling of large blocks or areas of the slope face. Similar to the “Extreme Hazard” zones, most of the “High Hazard” zones tend to be located along the actively eroding shoreline and similar life-threatening exposure to even minor rockfall is present along the base of the bluff slopes/cliffs in these areas (Plate 3).

“Hazard” zones were also delineated primarily on the basis of extensive fracturing of the slide masses/ground that has occurred as a consequence of continuing long-term displacement of the landslides. Relatively large horizontal and vertical ground displacements within these portions of the landslides have broken the slide masses into a myriad of blocks with intervening ground cracks and extensional zones. These ground cracks and extensional zones are subject to local ground collapse, and the slide debris is subject to shallow failure and rockfall in areas with significant slope gradients. As shown on Plate 3, the “Hazard” zones encompass all of the remaining areas of the Sunken City landslide and the shorefront slope that descends from the terrace level in the westerly portion of the Point Fermin landslide. In many of these areas, there are remnants of previous infrastructure improvements (primarily concrete slabs, along with local steel rails, abandoned pipes, etc.) that represent tripping, falling and local collapse hazards, in addition to, or associated with the local ground collapse and shallow failure potential.

Significant mitigation of the ground failure hazards can be accomplished in the inland portions of the Sunken City Landslide, but not to the degree that supports a recommendation allowing public access. The longevity of these mitigation measures would be limited by the effects of continuing wave erosion and landslide movement. Coastal permitting issues may also severely constrain or possibly prohibit mitigation grading in the slide area, particularly in the

The upper terrace area comprising the top of the Point Fermin Landslide mass in the inland areas away from the ocean shoreline and bluff top have not been identified as a significant ground failure hazard zone, and controlled public access to this area is considered feasible, pending implementation of an appropriate monitoring program (Section 8.2) and other safety measures.

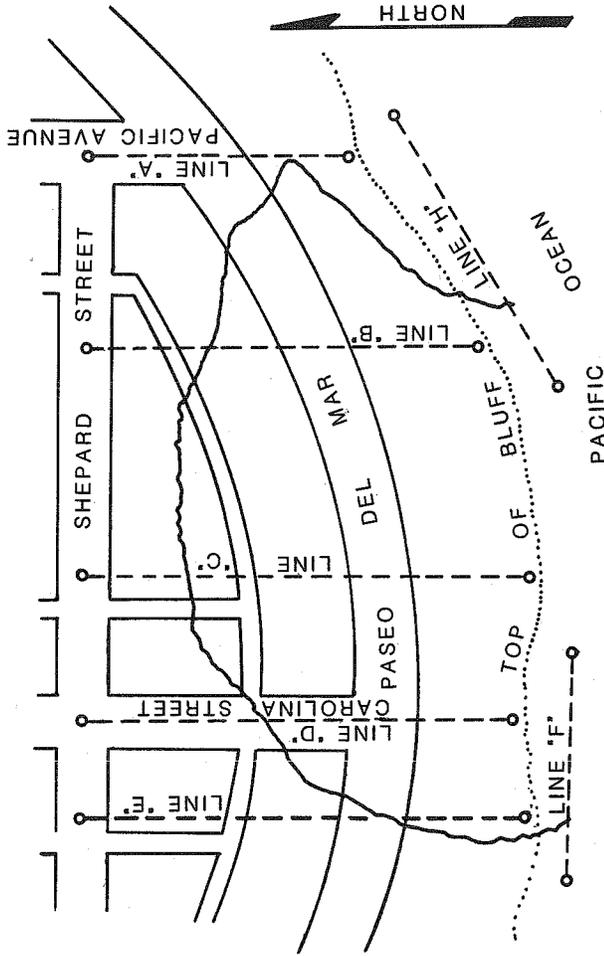
FIGURE A: 1929 Survey lines A-H, City of Los Angeles.

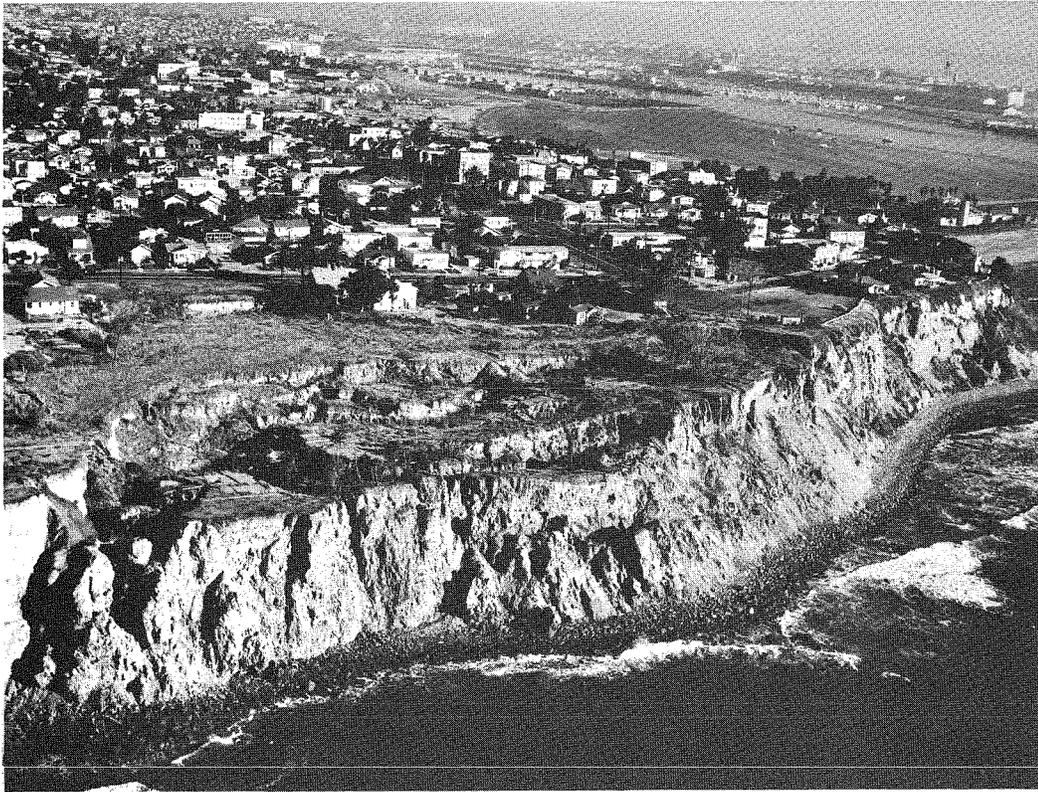
Figure 2. The active eastern portion of the Point Fermin Landslide. The photograph was taken from 500' elevation, looking north at 08:10 on November 24, 1959. The photograph (#3172) is courtesy of John S. Shelton of La Jolla, California.

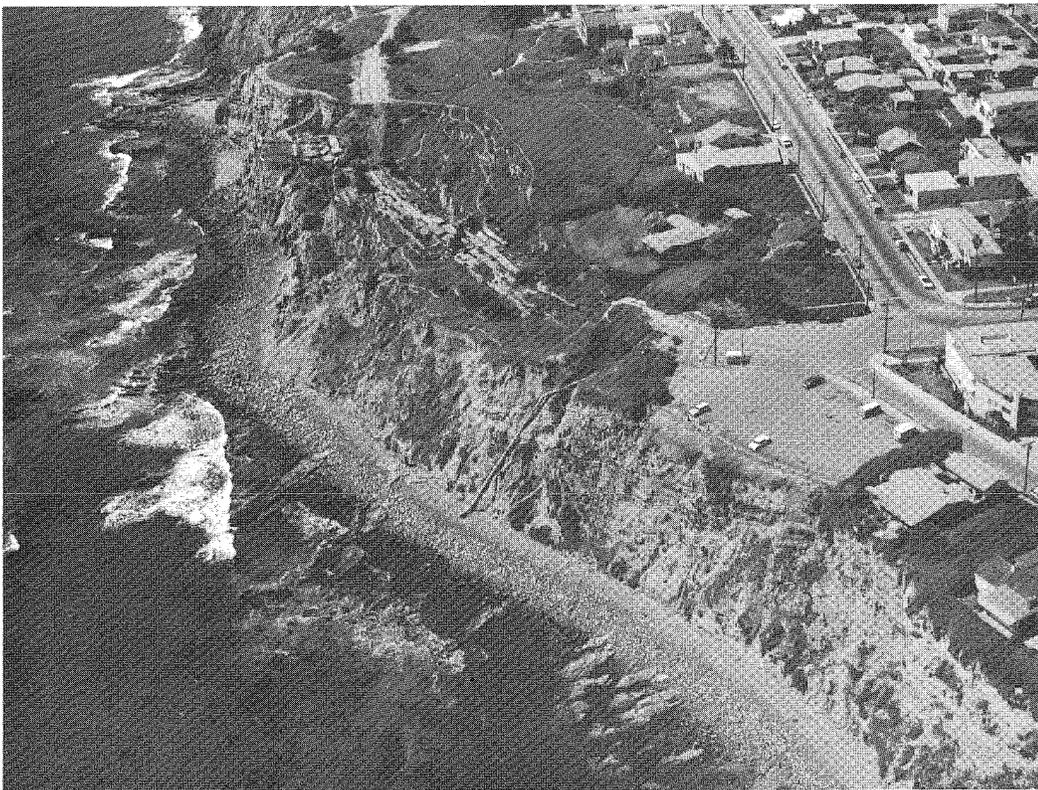
Figure 3. The photograph is looking westerly at the overall Point Fermin Landslide showing the active easterly portion. Shepard Street northerly of the landslide and the southerly end of Pacific Avenue and parking lot is in the right hand portion of the photograph. The photograph (#74311, 1974) is by John Shadle, photographer; courtesy of the City of Los Angeles, Department of Building and Safety.

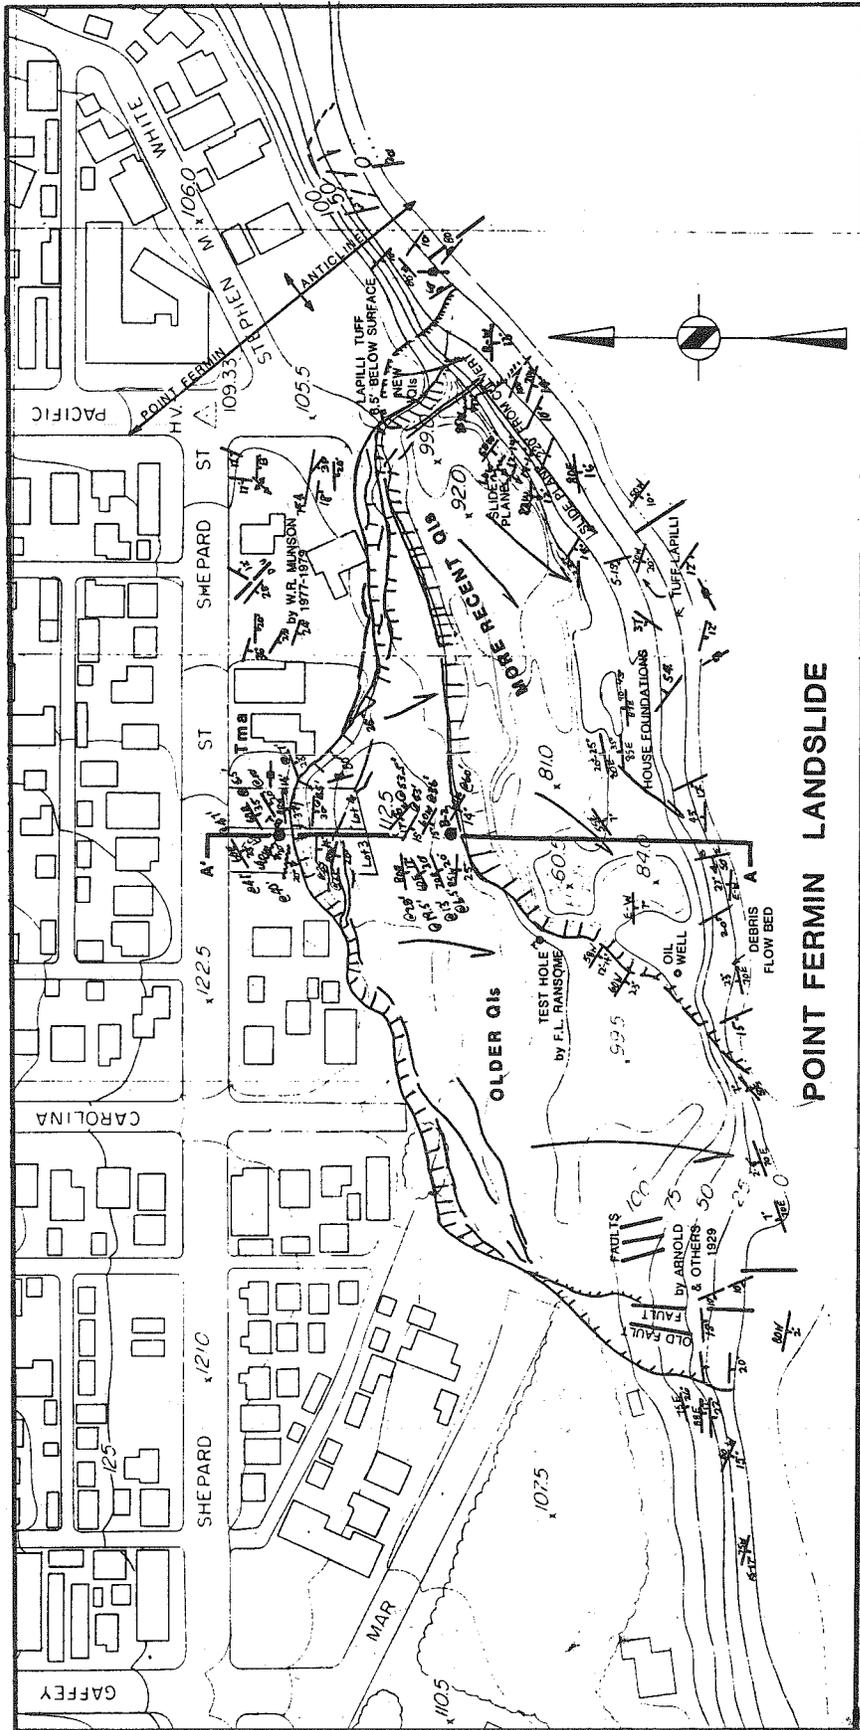
FIGURE 6: Geologic map of the Point Fermin landslide.
