Engineering Geologic Evaluation Sunken City / Point Fermin Landslide

Potential Ground Failure Safety Issues Associated with Public
Use of the Landslide Area

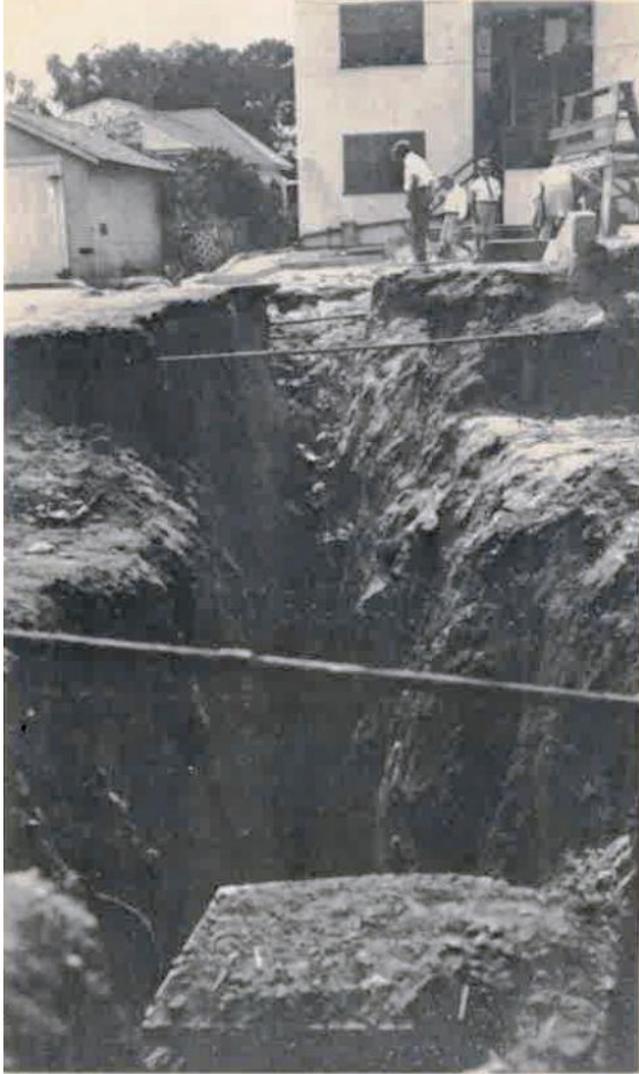
Photograph A.

1929 Back or Head of the Landslide Block

Looking west along the major fissure at the point of greatest displacement near the middle of the crescent. Considerable filling material has been dumped in the crevice at this point.

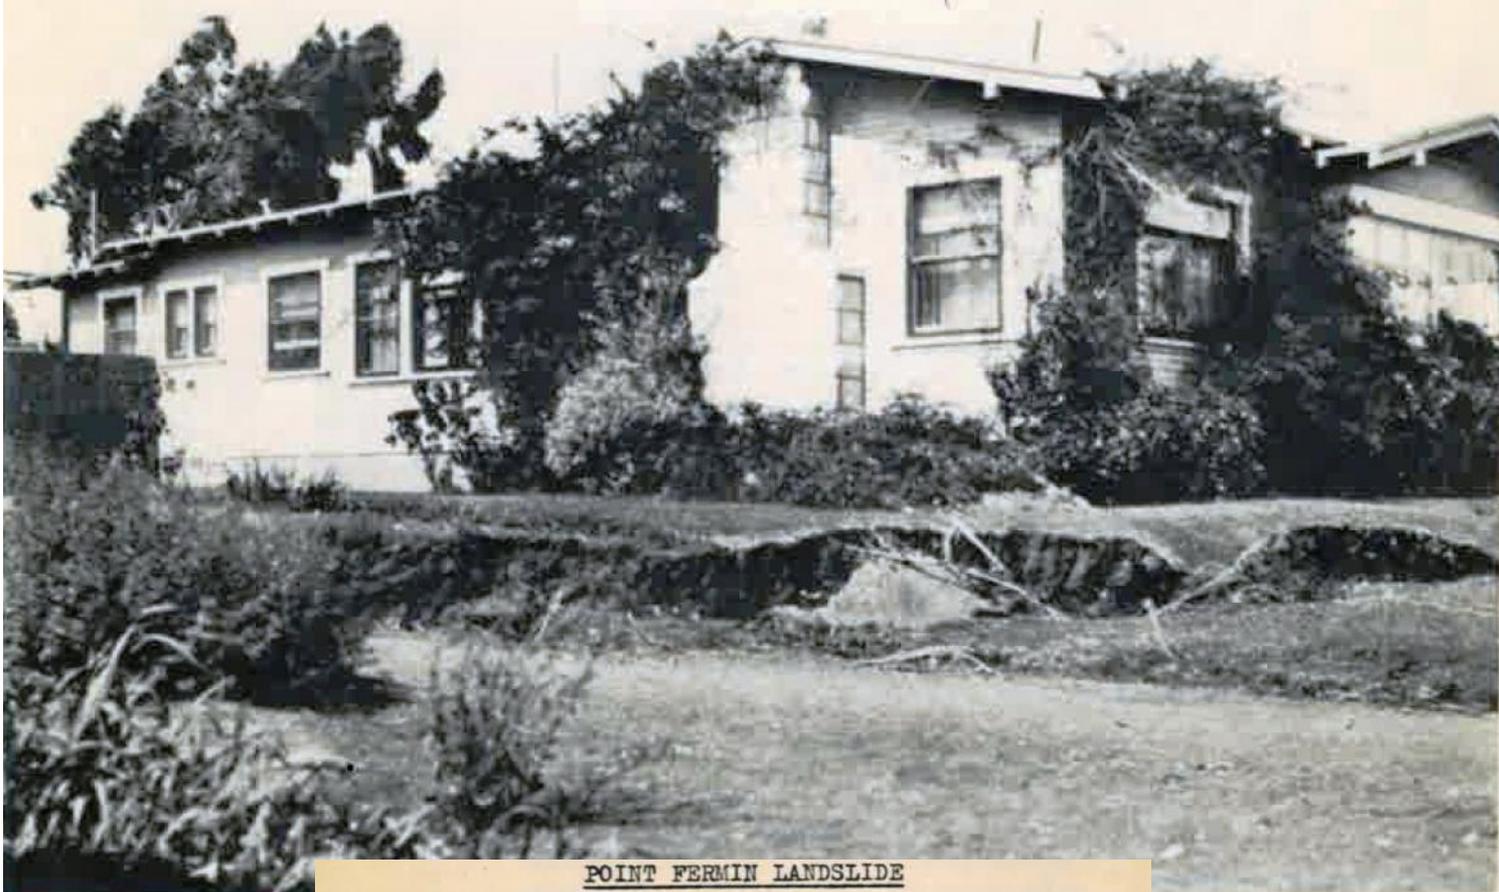
Photograph B.

1929 Head of Landslide Near Pacific Avenue

Looking northeast at the main crevice near the eastern end of fissure.

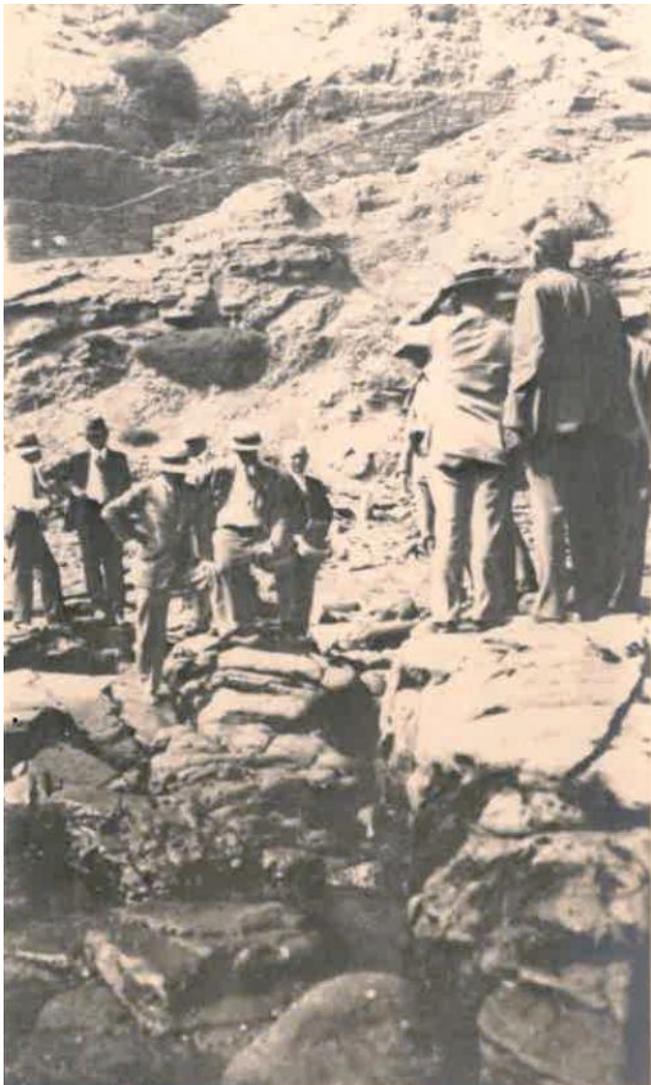
Photograph C.

1929 Displacement of Bedrock in the Intertidal Zone on the West Side of the Landslide Block

Looking north at the main fissure as developed in the rocks at tide level on the beach at the west side of the block.

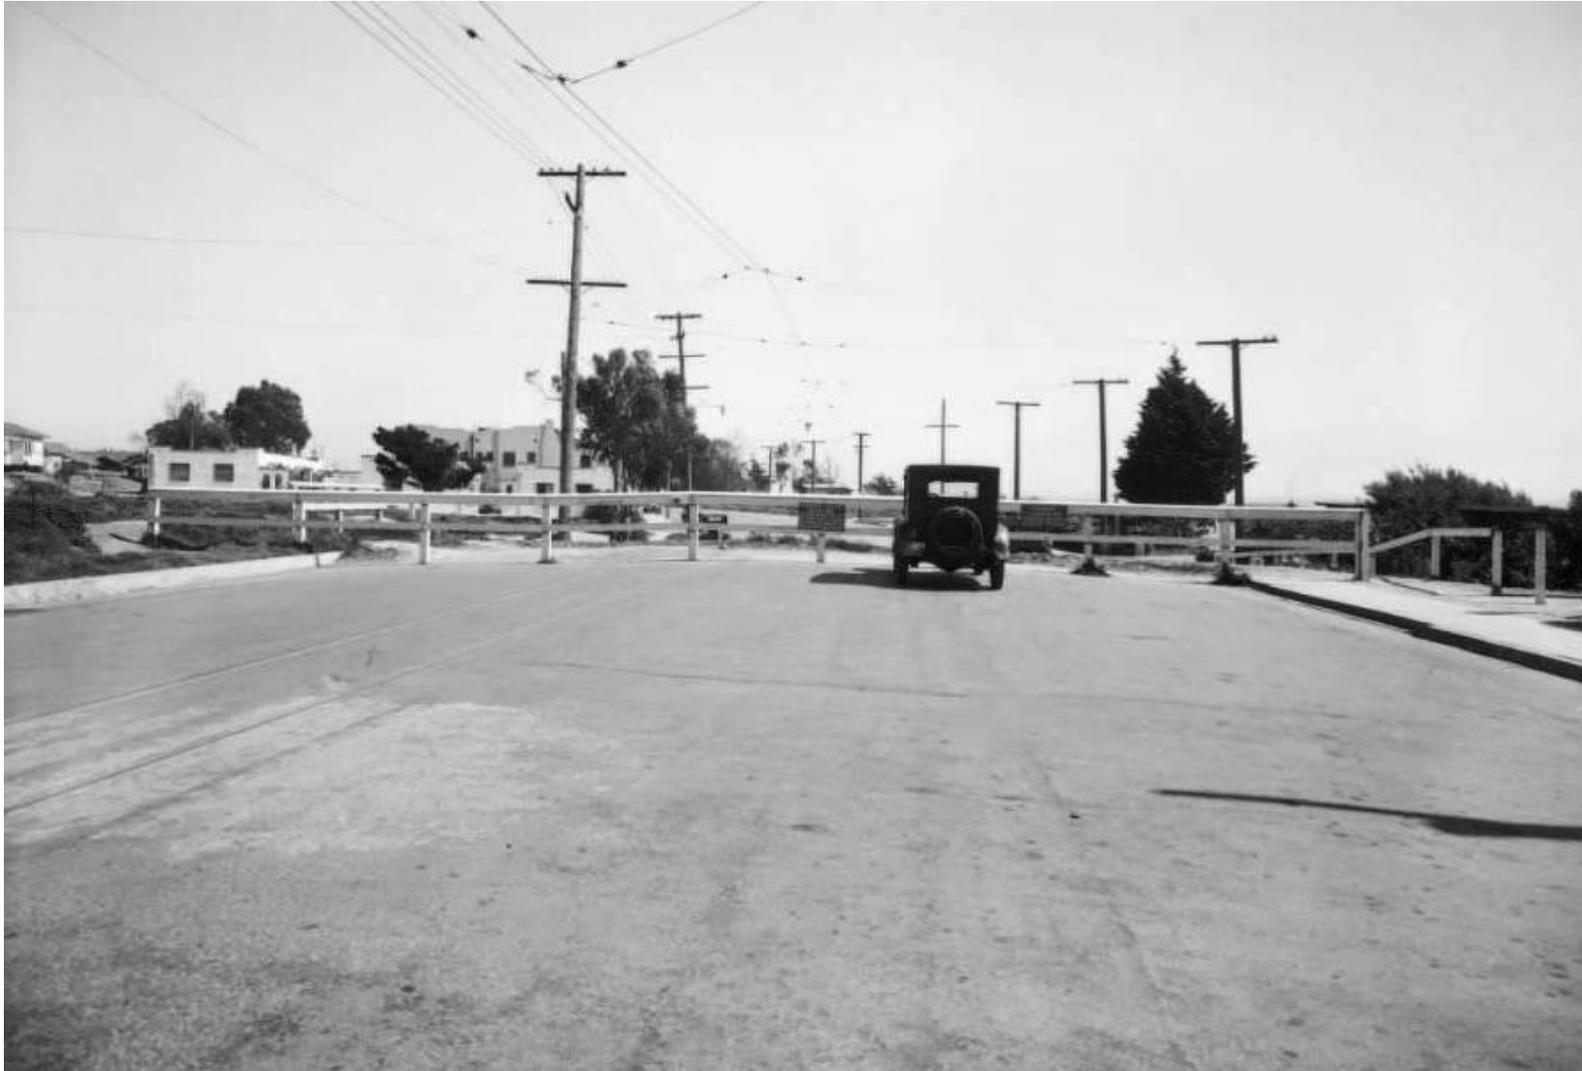
1932 - View East along Paseo Del Mar at Westerly Point Fermin Landslide Boundary

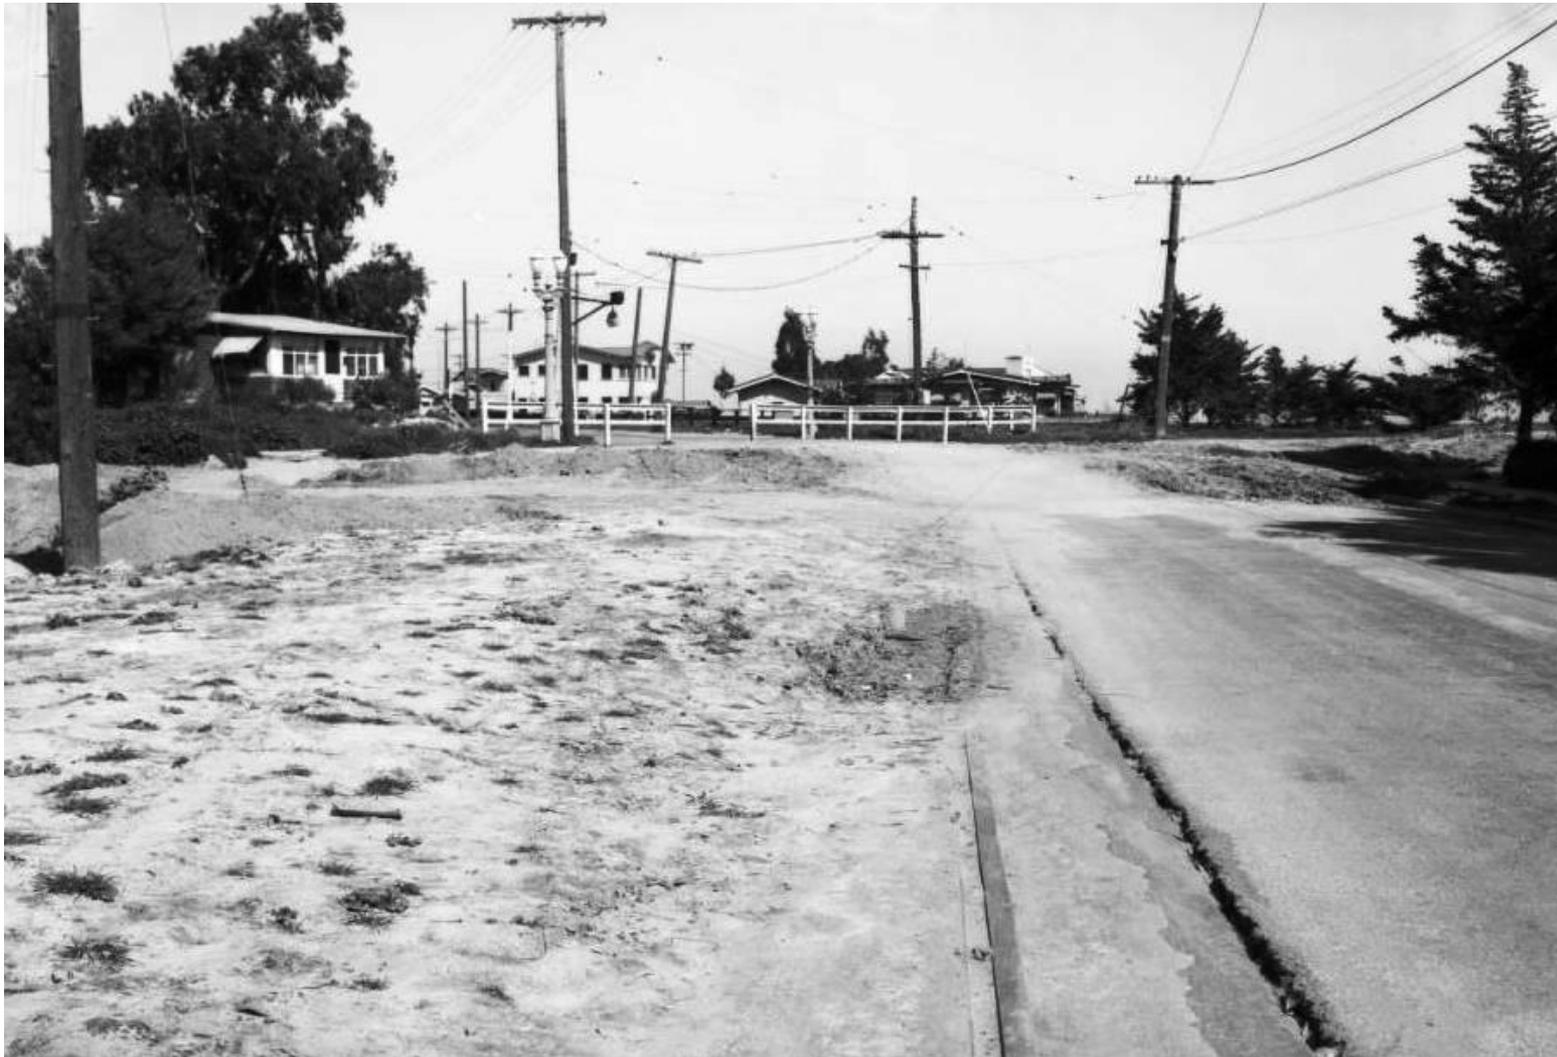
1932 - View East along Paseo Del Mar at Easterly Point Fermin Landslide Boundary

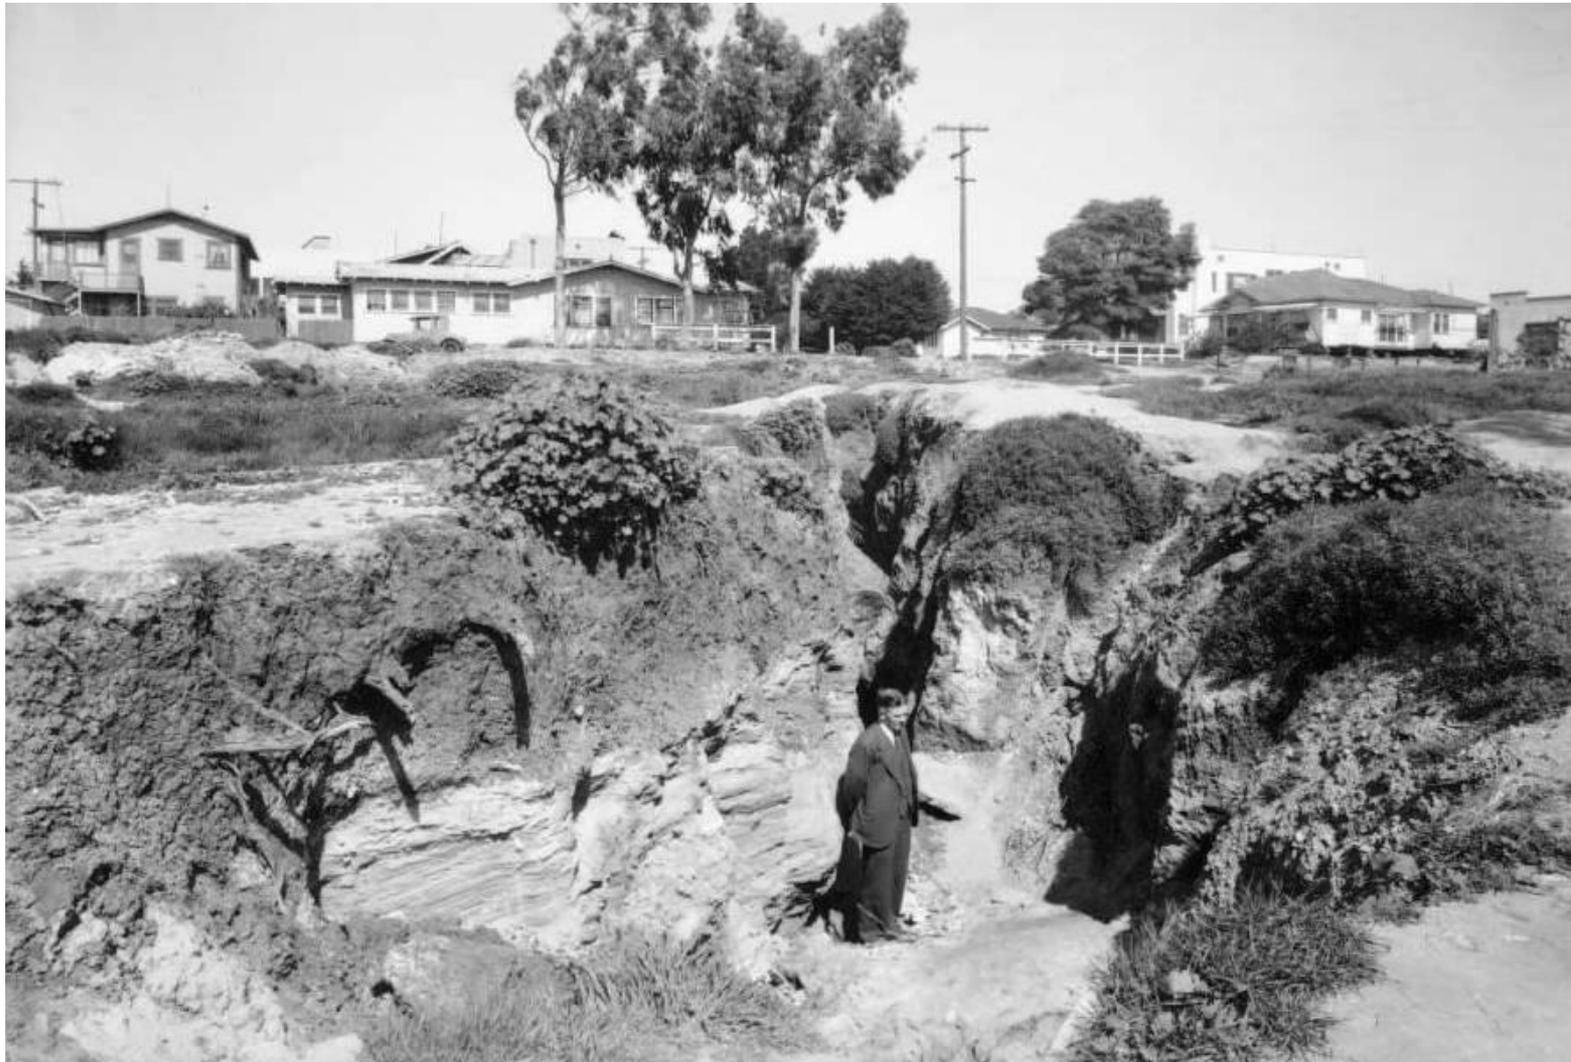
1932 - Ground Fissure or Crevice at the back of the Eastern Portion of the Point Fermin Landslide

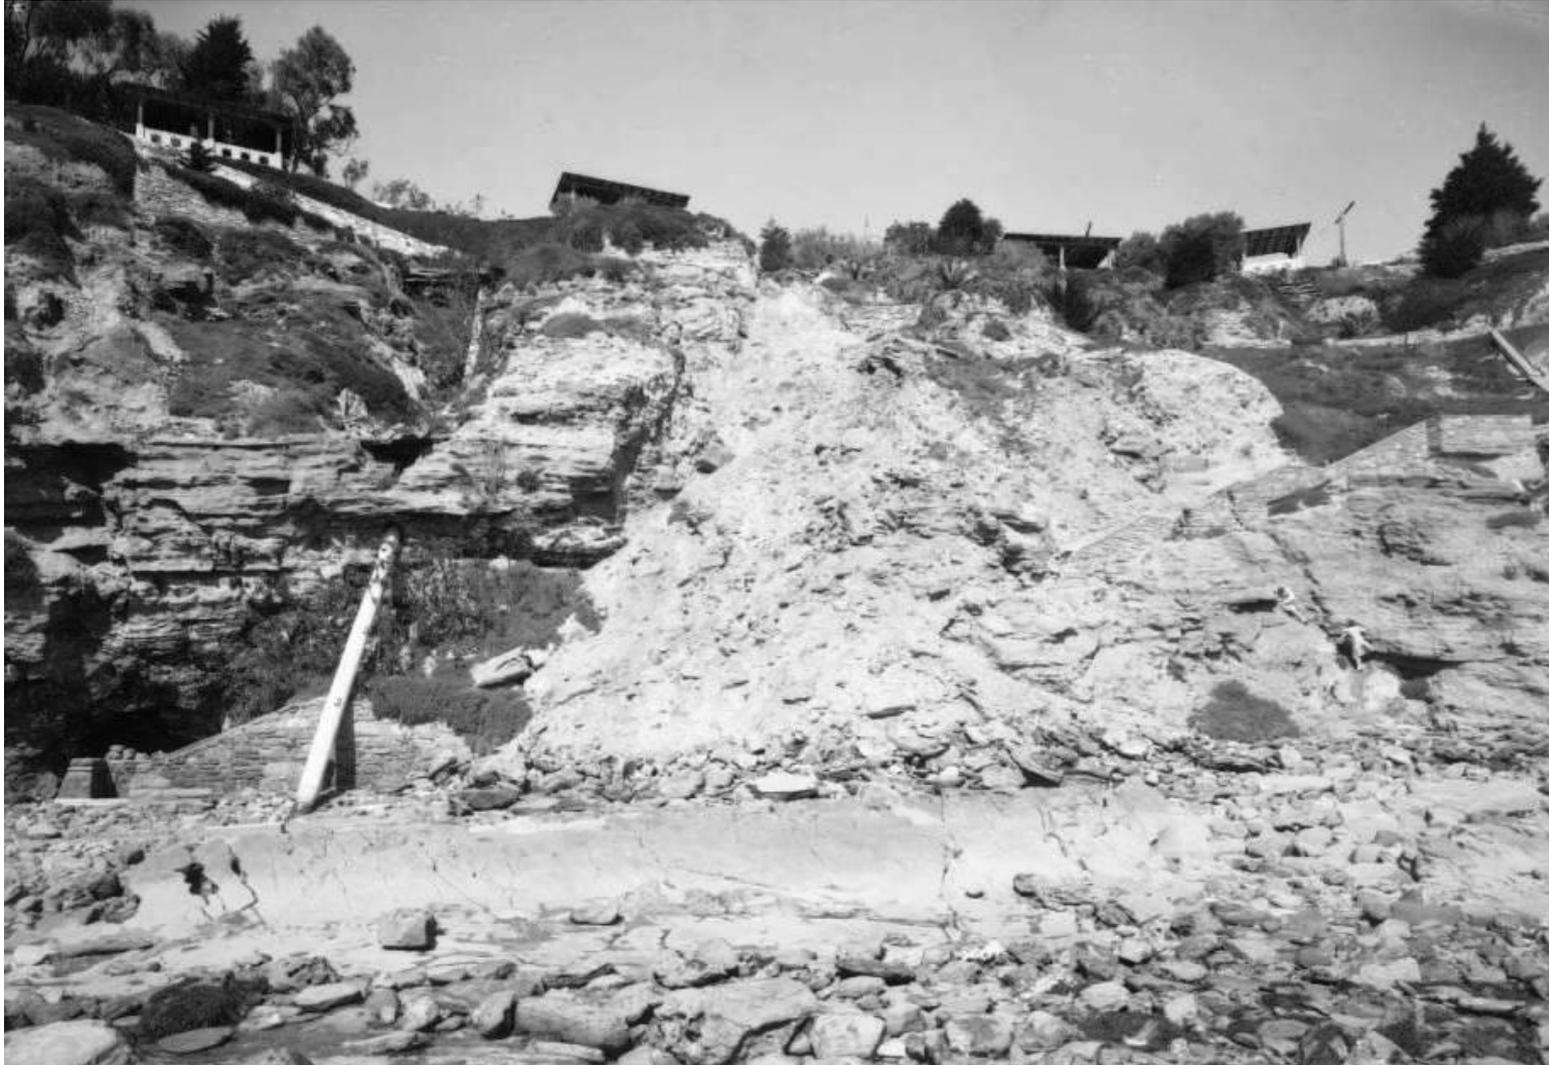
1932 - Westerly Boundary of Landslide at the Ocean Shoreline

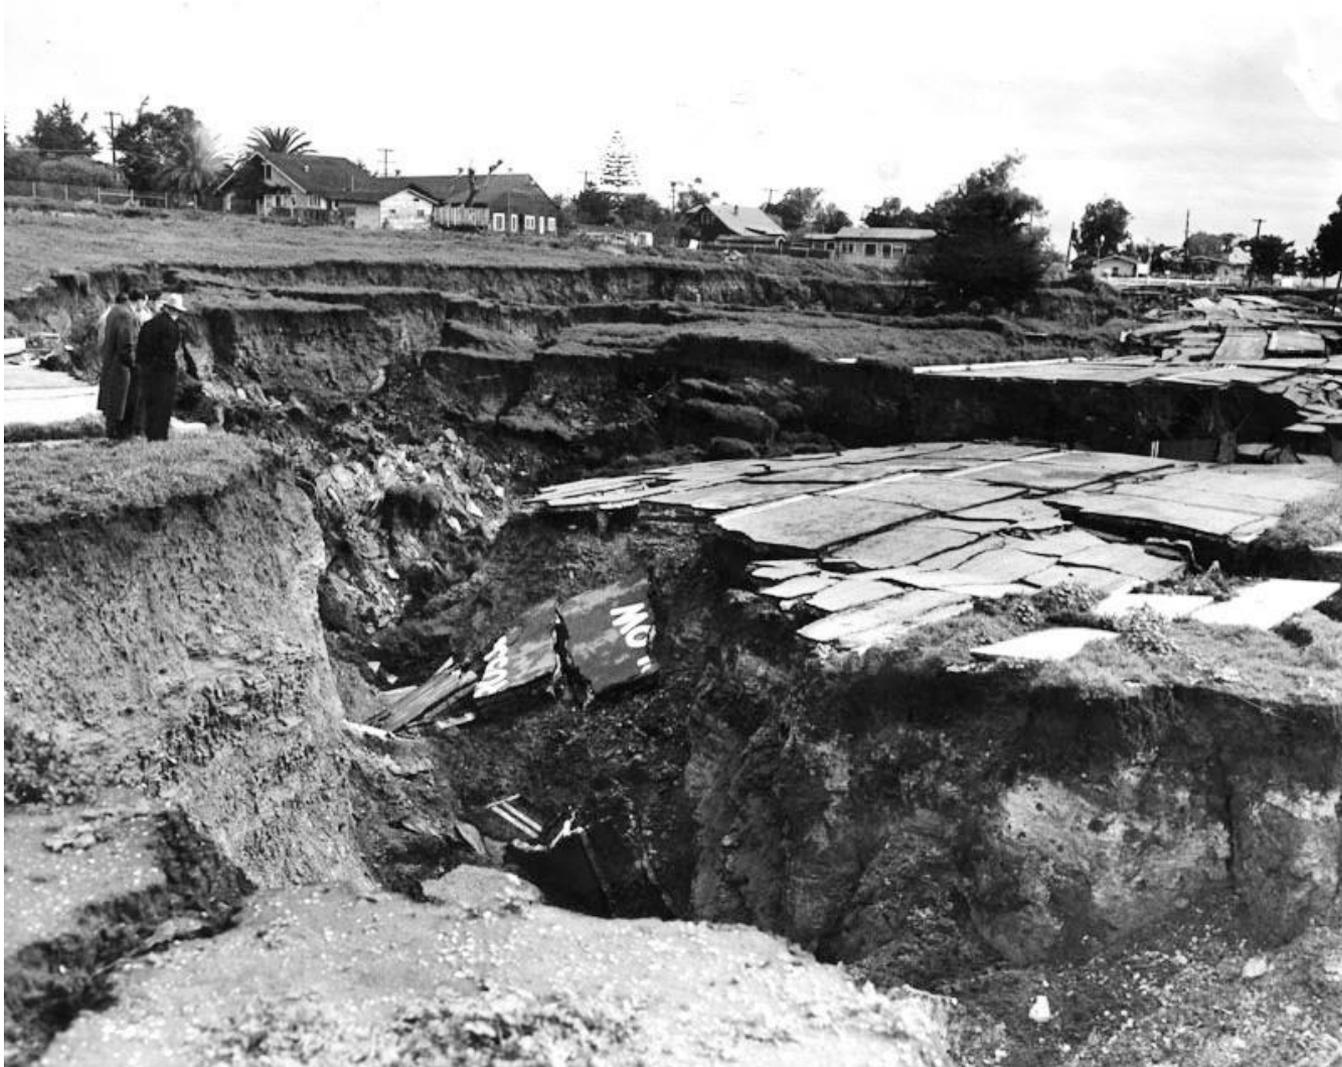
1941 – Sunken City Portion of the Landslide

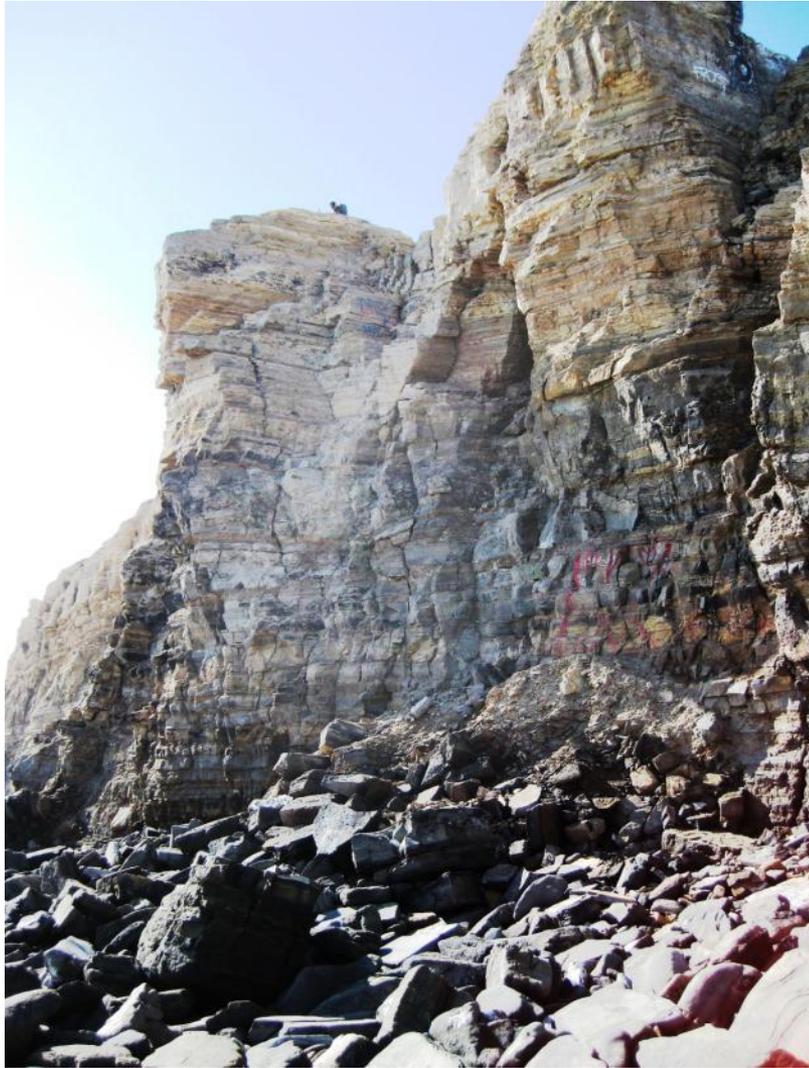
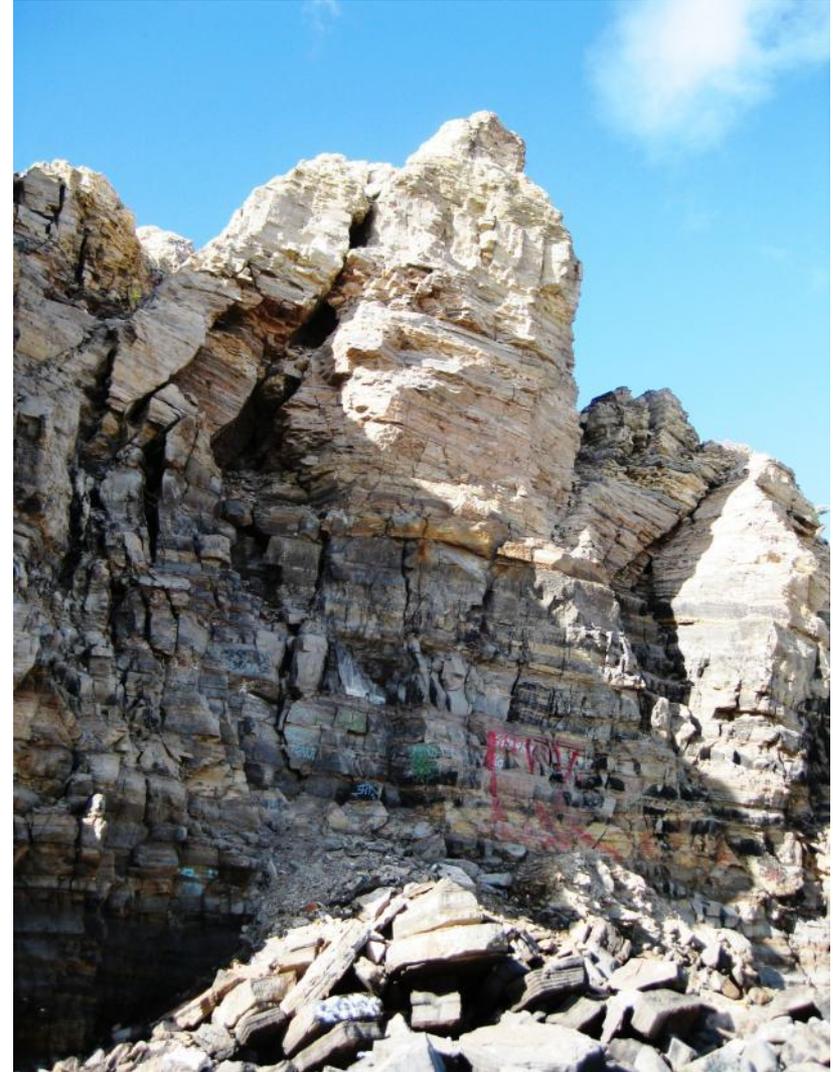
- ▶ Recent personal observations in December 2015 and early March 2016 indicated significant erosion had occurred in the interim along the toe of the slide area in response to relatively high surf conditions; the observed conditions were consistent with active movement of the Sunken City portion of the landslide.
-

March 2016 - Sunken City Landslide Bluff Face and Beach Debris Piles

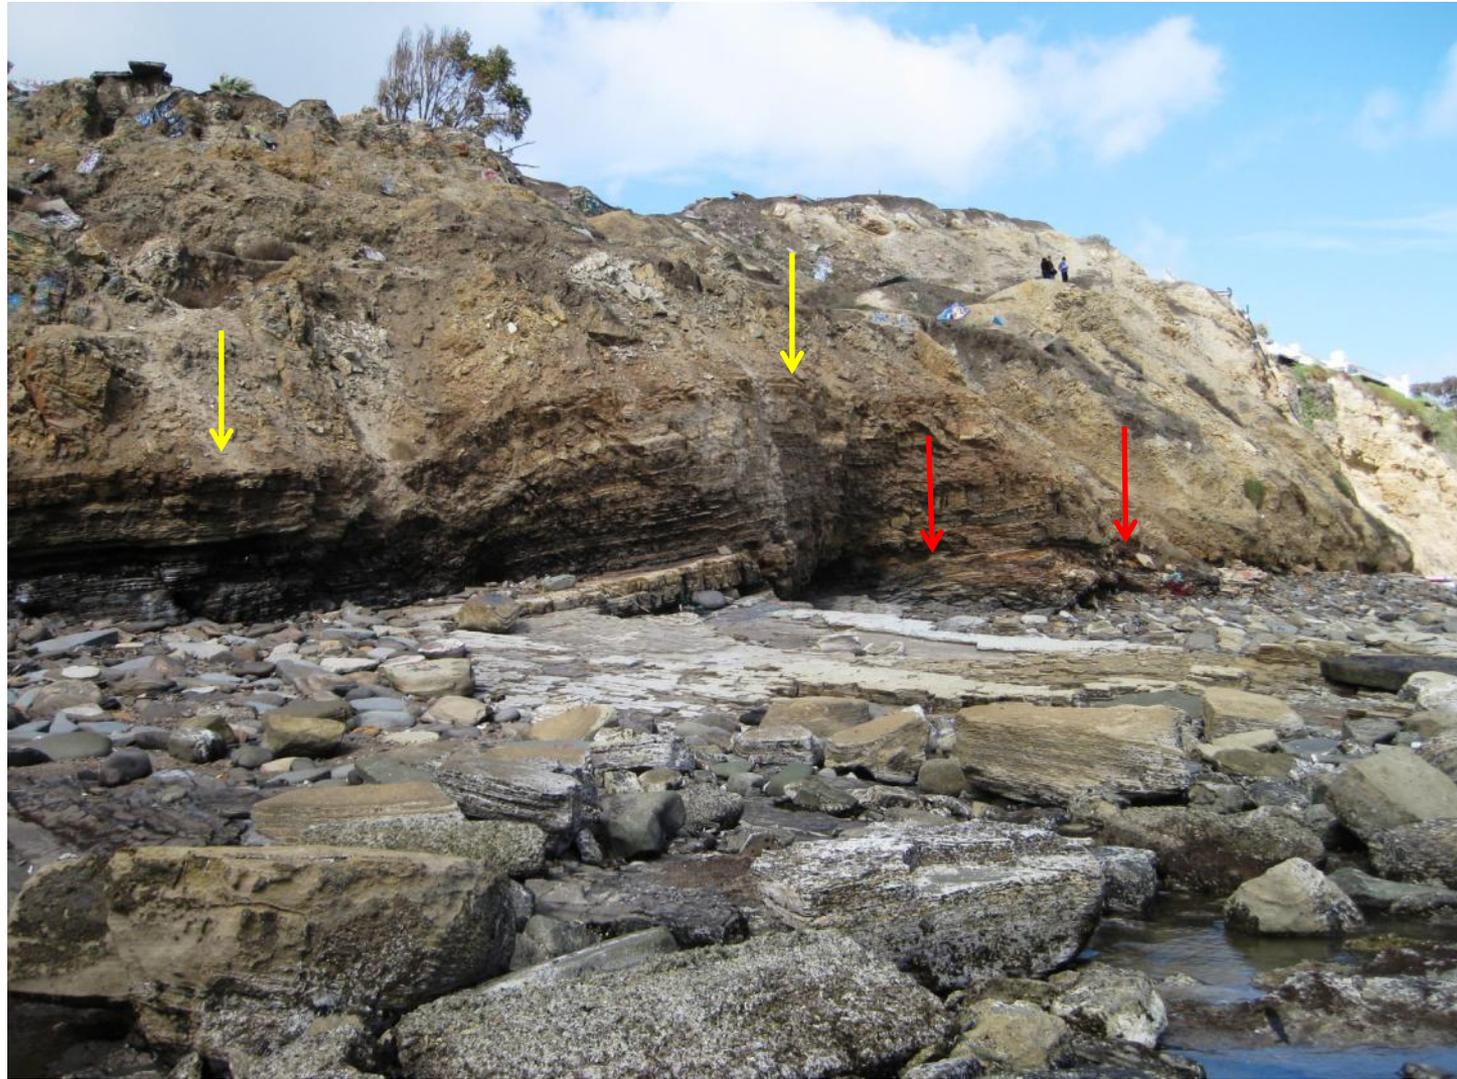
Exposed Base of Pont Fermin Landslide (red arrows) and Sunken City Landslide (yellow arrows)

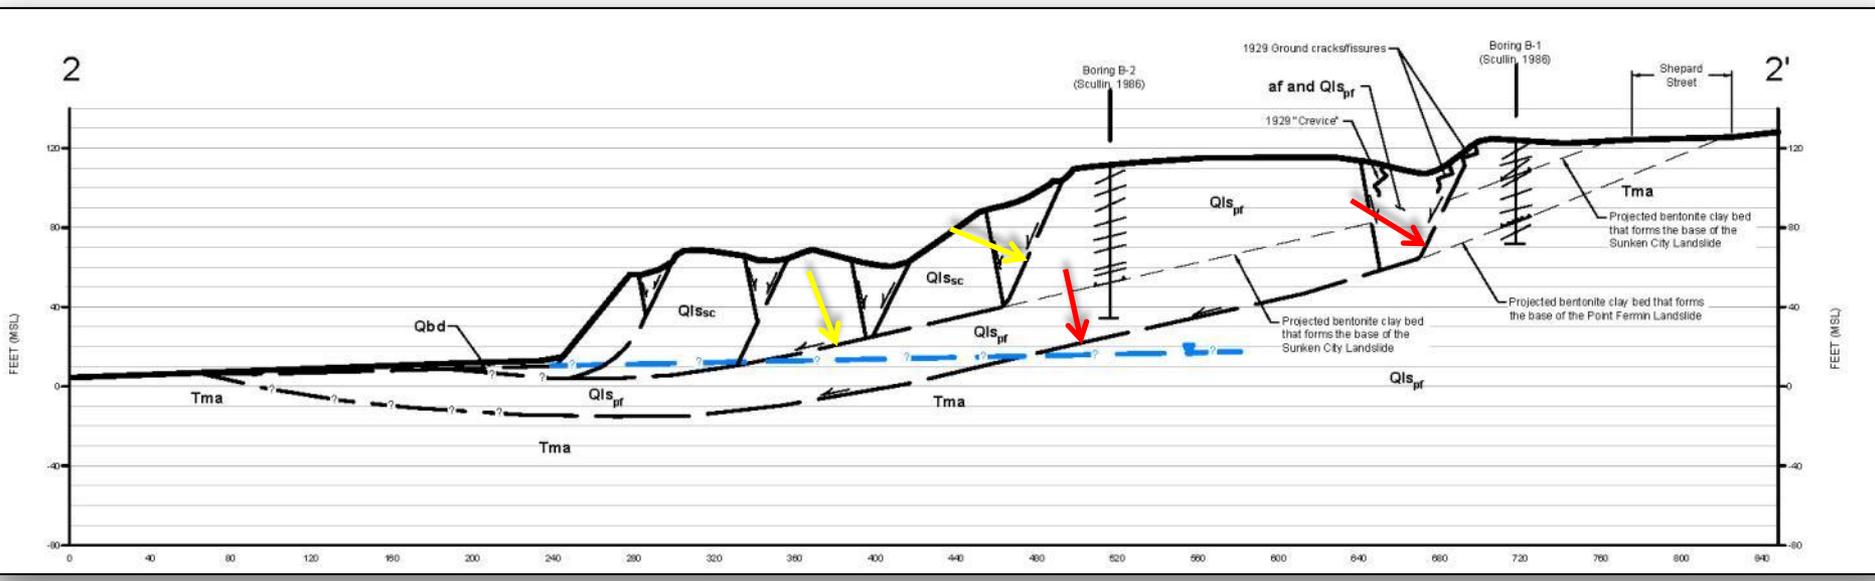
Geologic Cross-Section 2 – 2' Near the Center of the Landslide Area (Point Fermin LS: red arrows, Sunken City LS: yellow arrows)

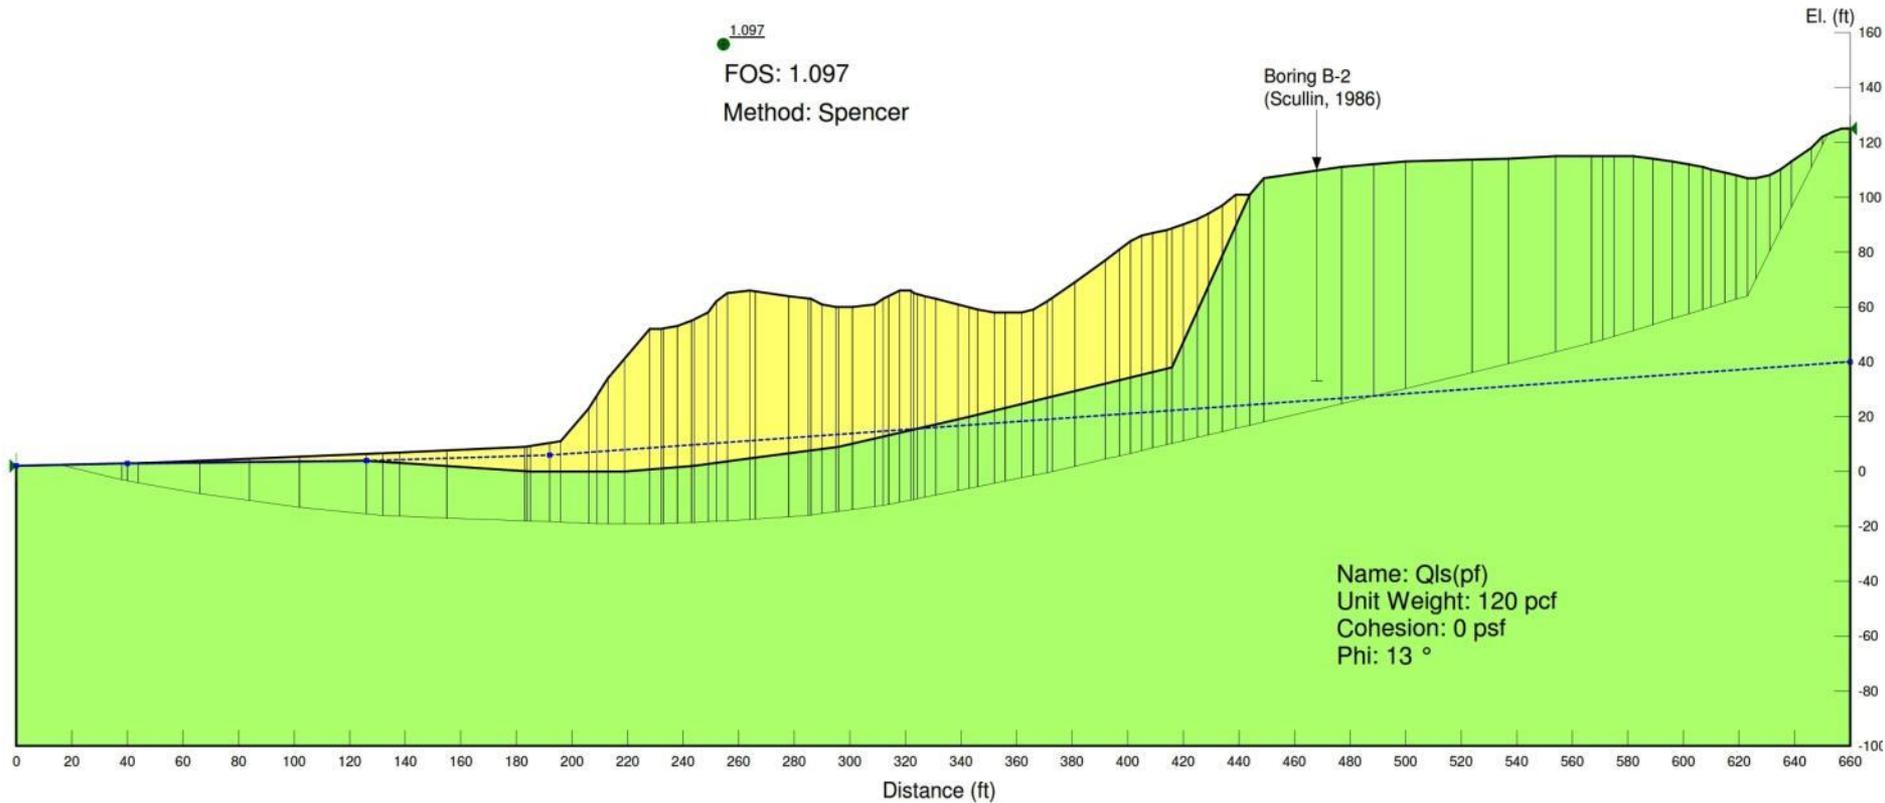
Calculated Phi-Angle for Near-Equilibrium Condition: PFLS Section 2-2' (Phi = 13 degrees)

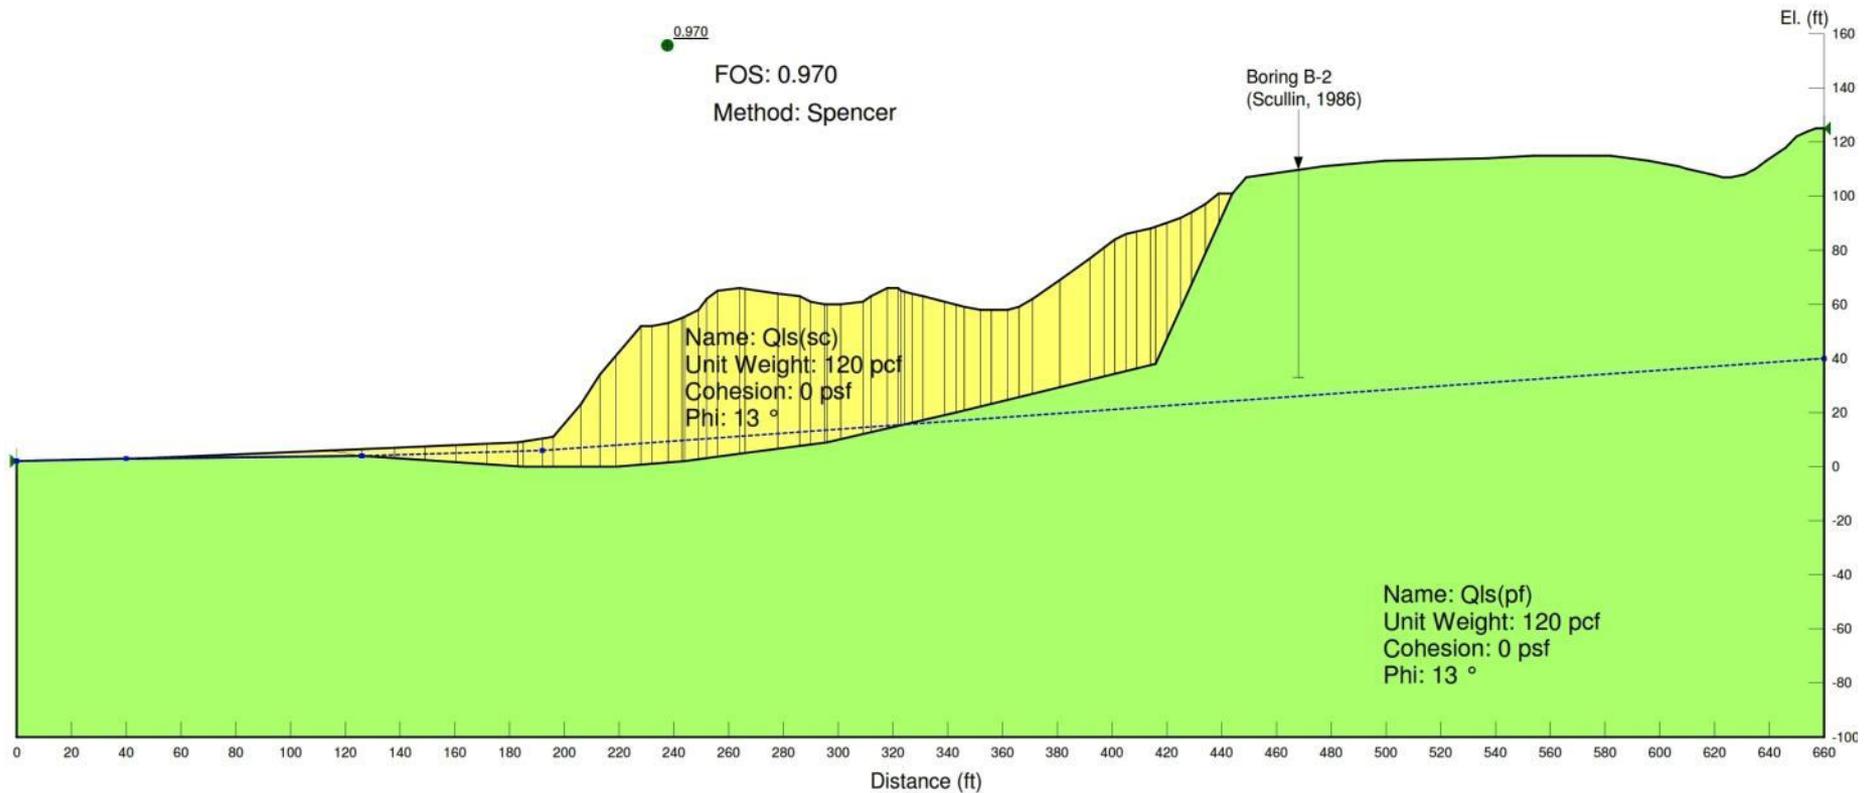
Calculated Phi-Angle for Near-Equilibrium Condition: SCLS Section 2-2' (Phi = 13 degrees)

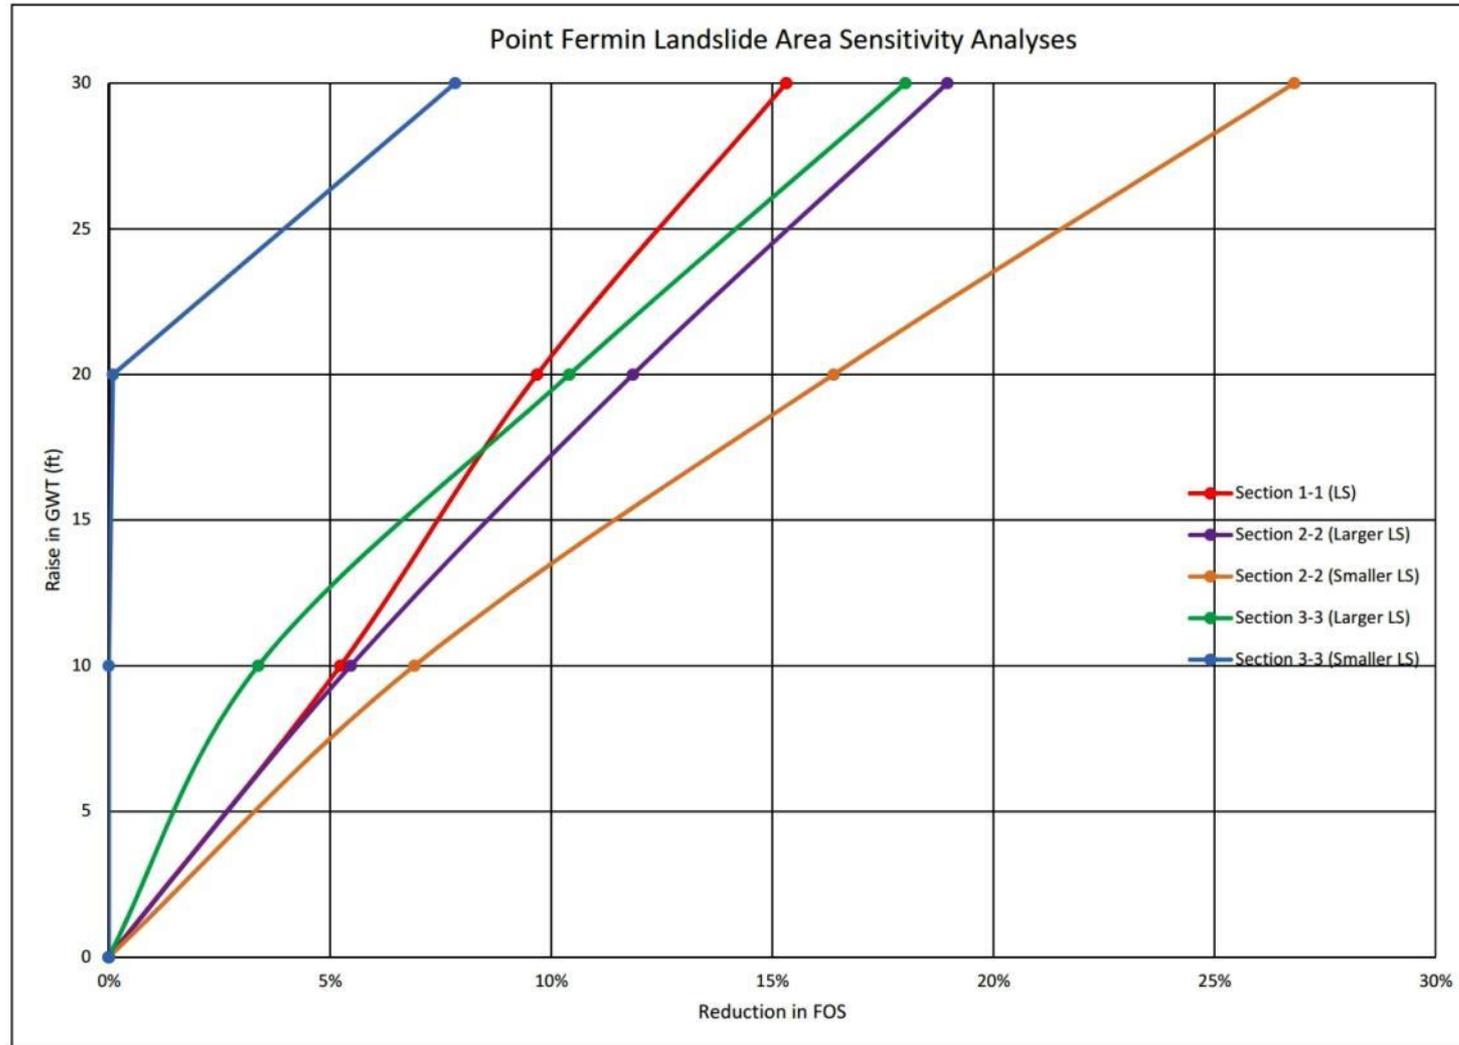
Sensitivity Evaluation of Rising Groundwater Levels on the Calculated F.S.

Section 2-2': a 20-foot rise in GW reduces F.S. 12% and 17%, respectively, for the PFLS and SCLS,

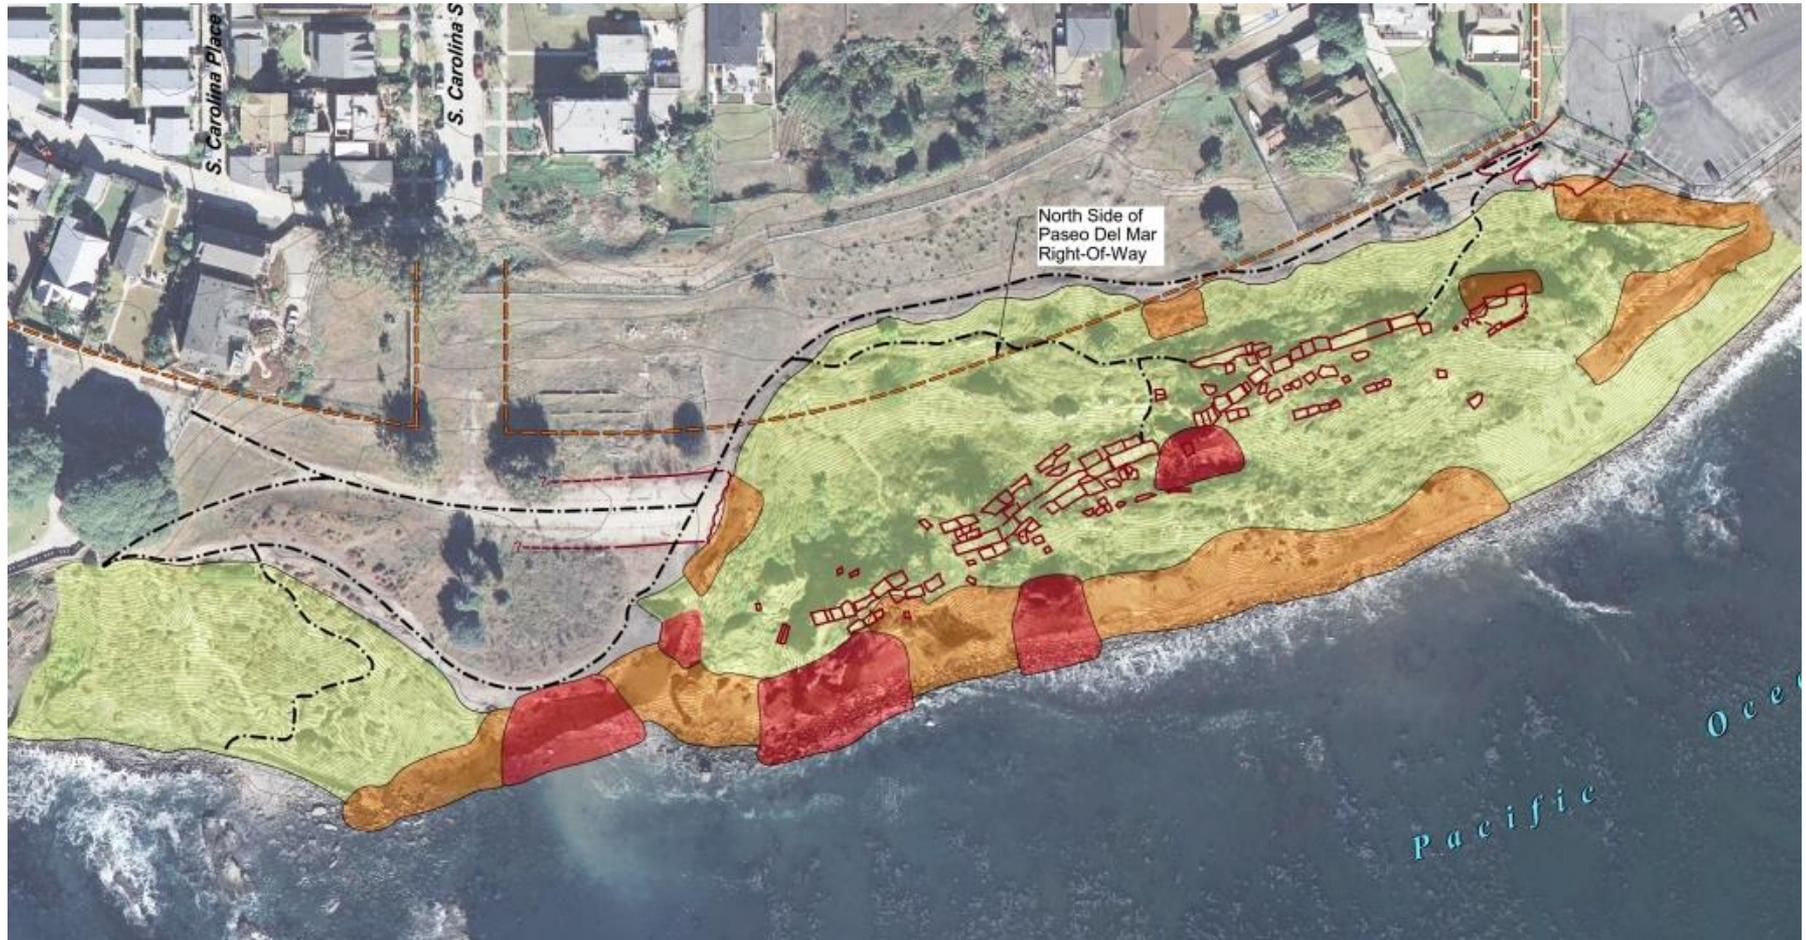
Primary Trails and Ground Failure Hazard Zones Map, Showing Displaced Concrete Road Slabs

**EXTREME HAZARD ZONE** - the presence of pervasive dilated fracturing within the bedrock comprising these relatively high, very steep slopes indicates a potential for life-threatening catastrophic failure that could occur at any time, affecting both the area above/behind, and also below the slope.

**HIGH HAZARD ZONE** - disturbance of the bedrock fabric from the extended period of ground movement within the landslide makes these relatively steep slope areas highly susceptible to shallow failure and/or rockfalls, primarily affecting areas on or below the slope.

**HAZARD ZONE** - relatively large horizontal and vertical ground displacements within these portions of the landslide have broken the slide mass into a myriad of blocks with intervening ground cracks and extensional zones, thus reducing much of the bedrock to rocky or blocky debris; these ground cracks and extensional zones are subject to local ground collapse and the slide debris is subject to shallow failure in areas with significant slope gradients.
