Engineering Geologic Evaluation Sunken City / Point Fermin Landslide

Potential Ground Failure Safety Issues Associated with Public
Use of the Landslide Area

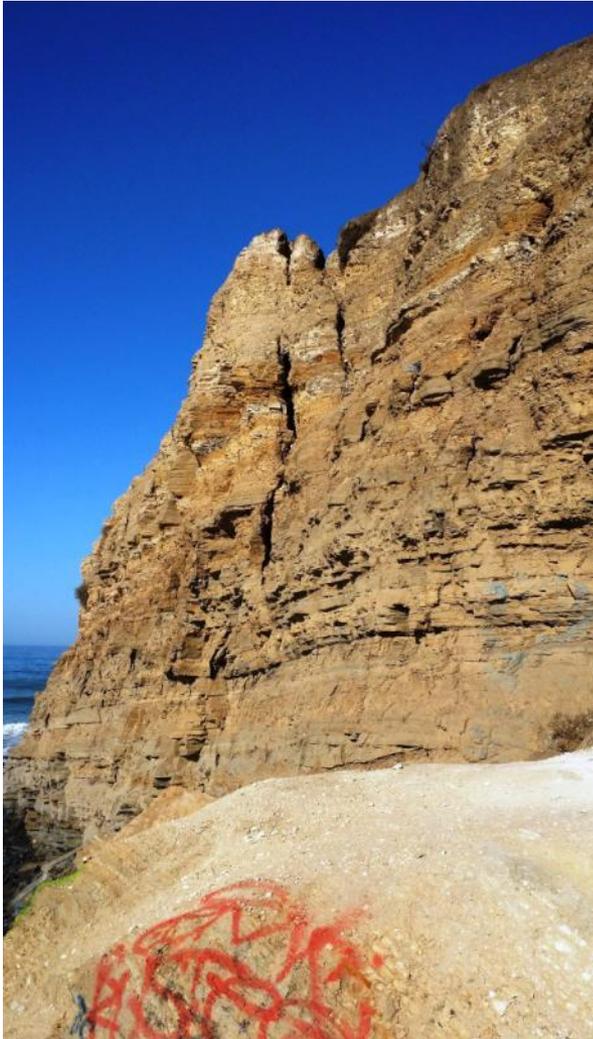
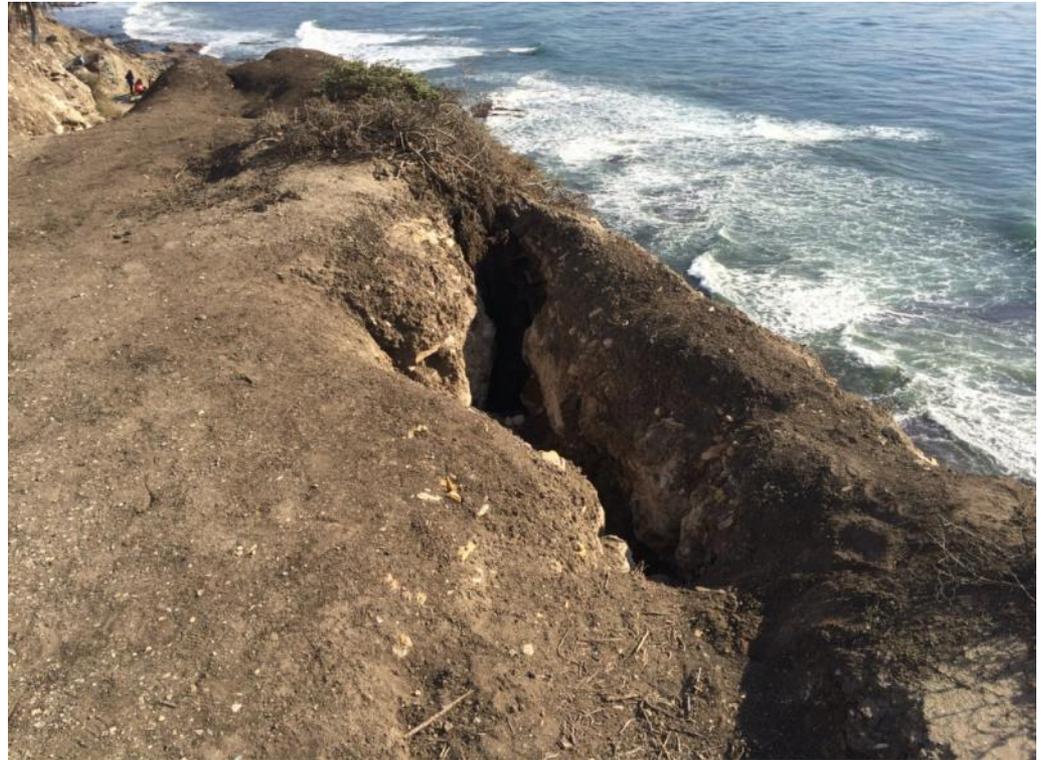
**EXTREME HAZARD ZONE** - the presence of pervasive dilated fracturing within the bedrock comprising these relatively high, very steep slopes indicates a potential for life-threatening catastrophic failure that could occur at any time, affecting both the area above/behind, and also below the slope.

Extreme Ground Failure Hazard Zones

- ▶ In general, because of their location on relatively high, very steep slopes, the only potential mitigation measures for the Extreme and High Hazard Zones along the ocean shoreline are avoidance or removal;
 - ▶ It must be recognized that any proposed grading removal involves significant safety concerns that would need to be addressed and the longevity of these mitigation measures would be limited by the effects of continuing wave erosion;
 - ▶ Coastal permitting issues may also severely constrain or prohibit mitigation grading of the existing bluff slopes;
 - ▶ The possible legal ramifications of grading modification of what through time will likely continue to be an unsafe area will also need to be considered.
-

- ▶ Extreme and High Hazard Zones inland from the ocean shoreline are much more amenable to grading mitigation measures that would primarily consist of regrading these relatively steep slope areas to gradients shallower than 1:1 (H:V); this is sometimes referred to as a “slope layback”;
 - ▶ A slope layback will not be possible in most of the High Hazard Zone at the easterly extremity of the landslide area because of the proximity of the adjoining offsite parking area; installation of a tieback shoring wall at this location could be considered, which will also control additional northeastward enlargement of the landslide area;
-

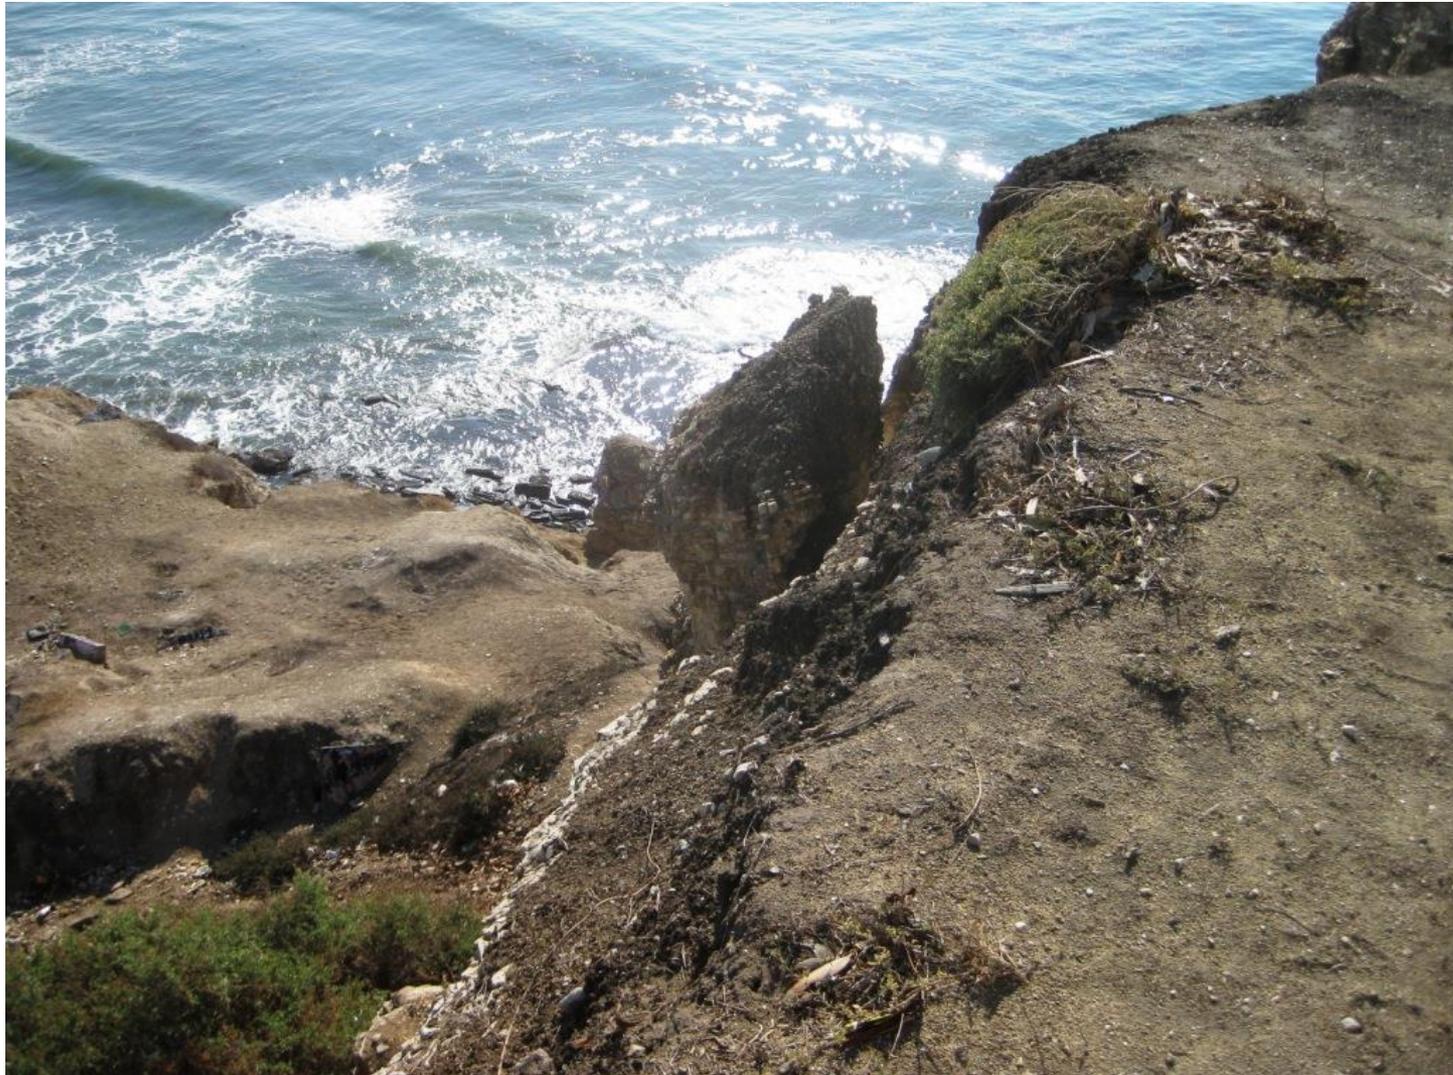
Extreme Ground Failure Hazard Zones

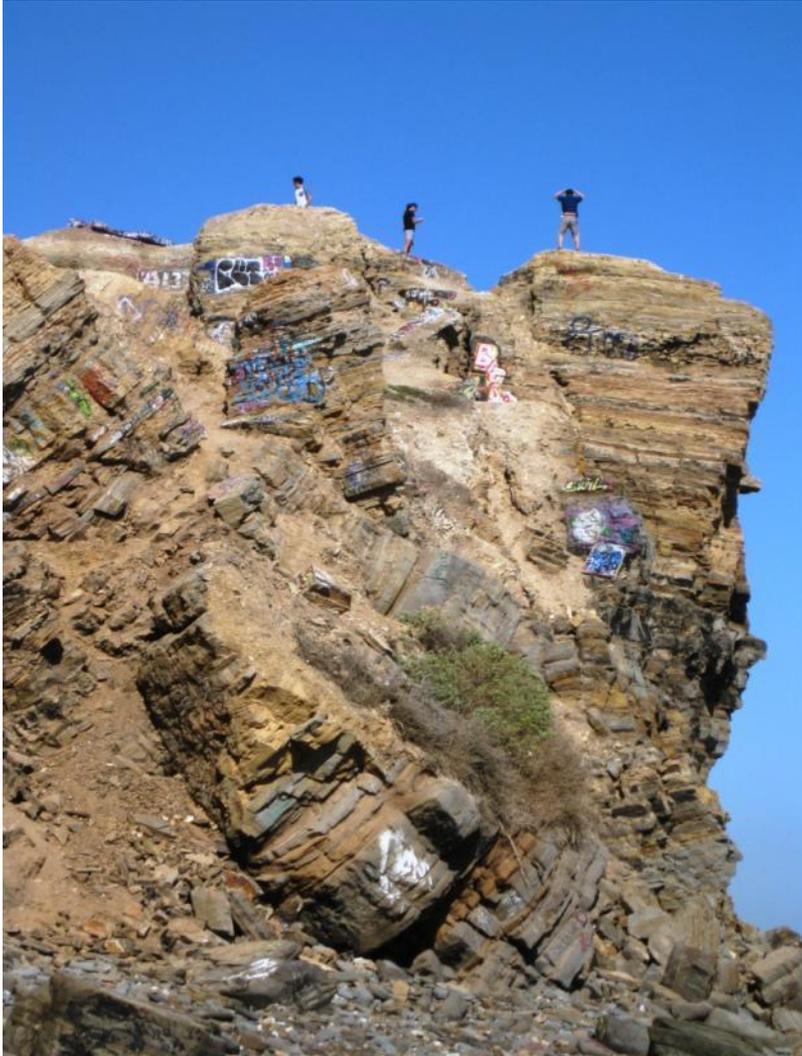
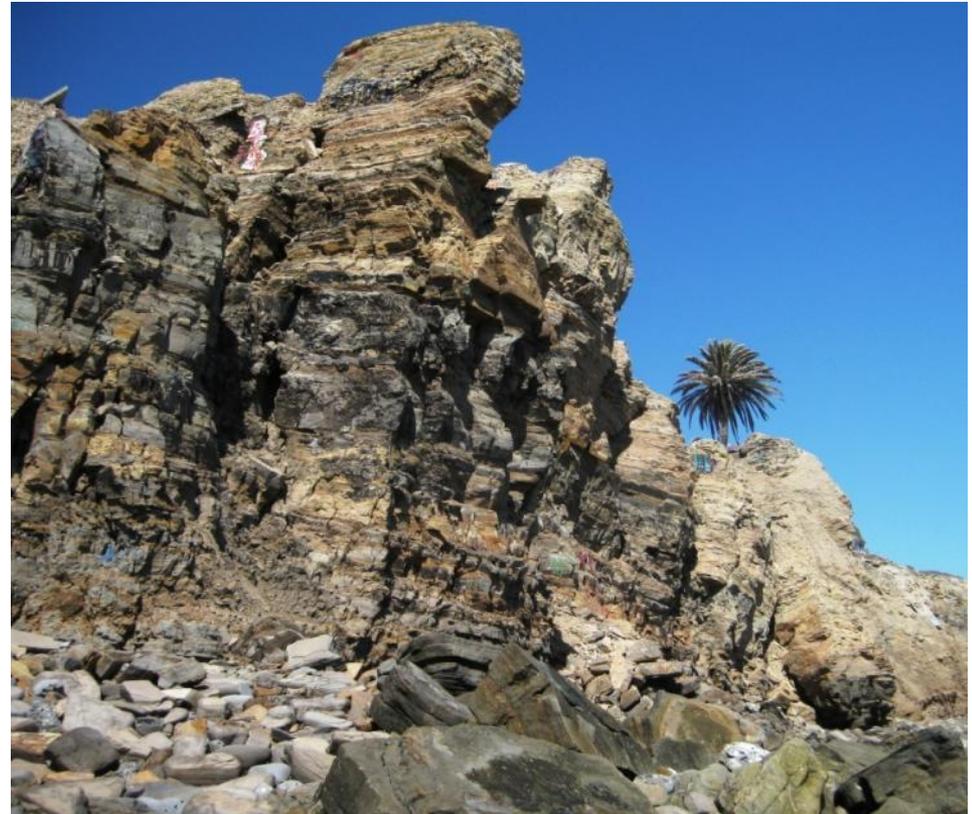
Extreme Ground Failure Hazard Zones

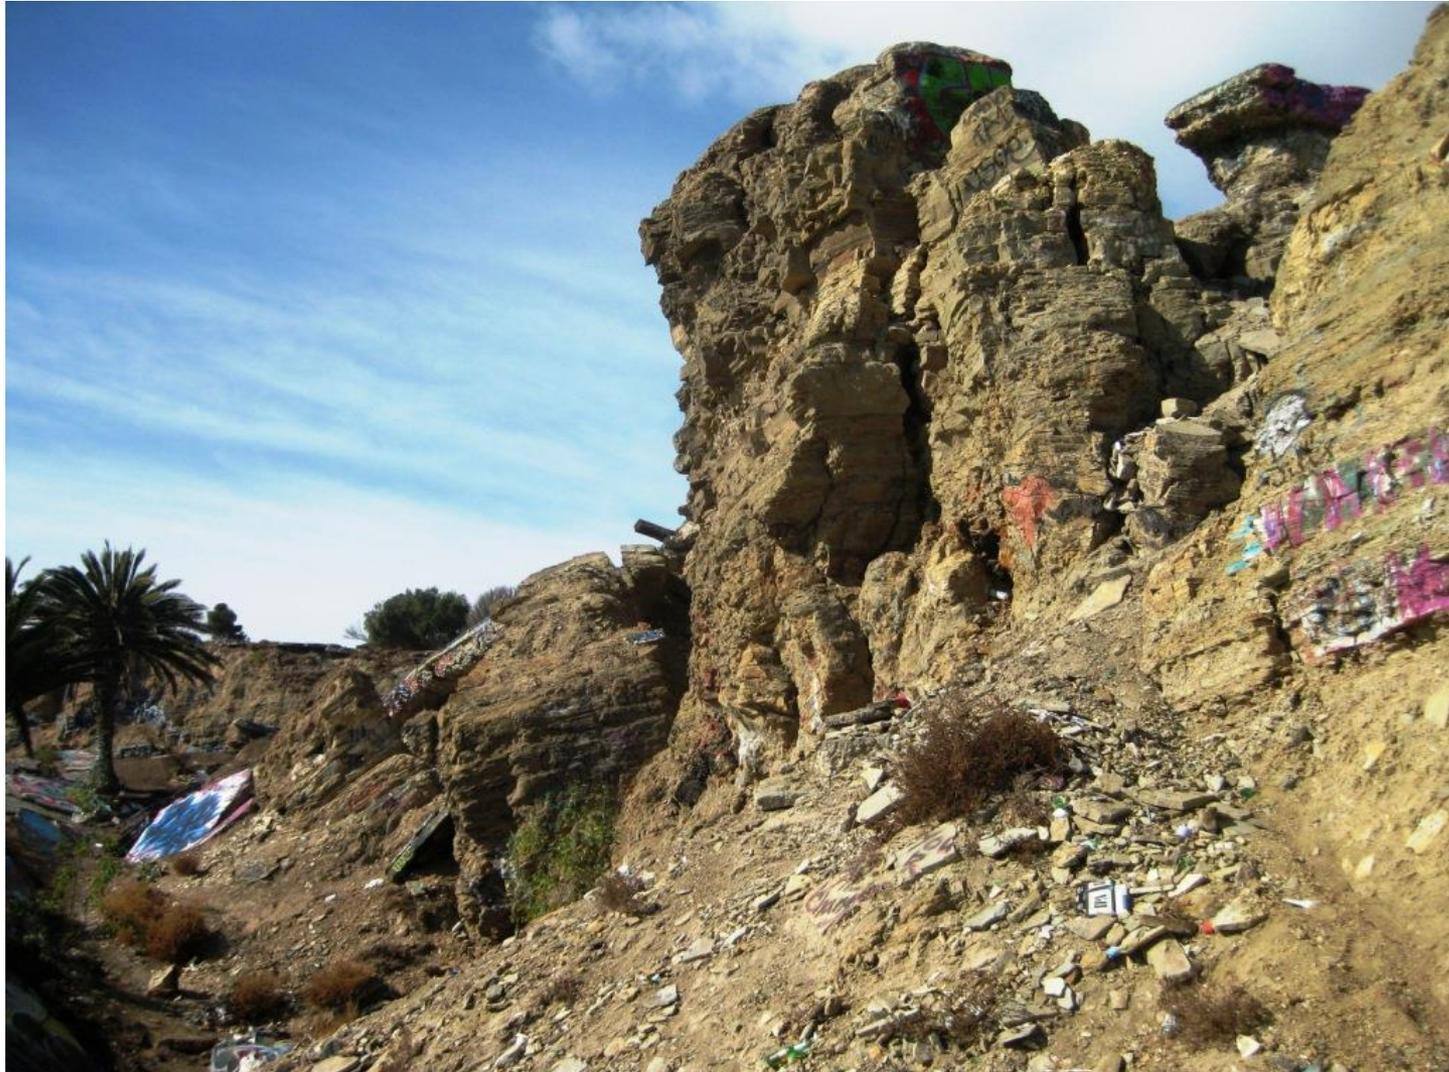
Extreme Ground Failure Hazard Zones
