# **SUNKEN CITY LANDSLIDE – PRELIMINARY FEASIBILITY STUDY**

Task Order Solicitation GEO File No. 15-160  
Point Fermin Park Area, San Pedro  
Los Angeles, California

December 23, 2016

Project No. IR16166090

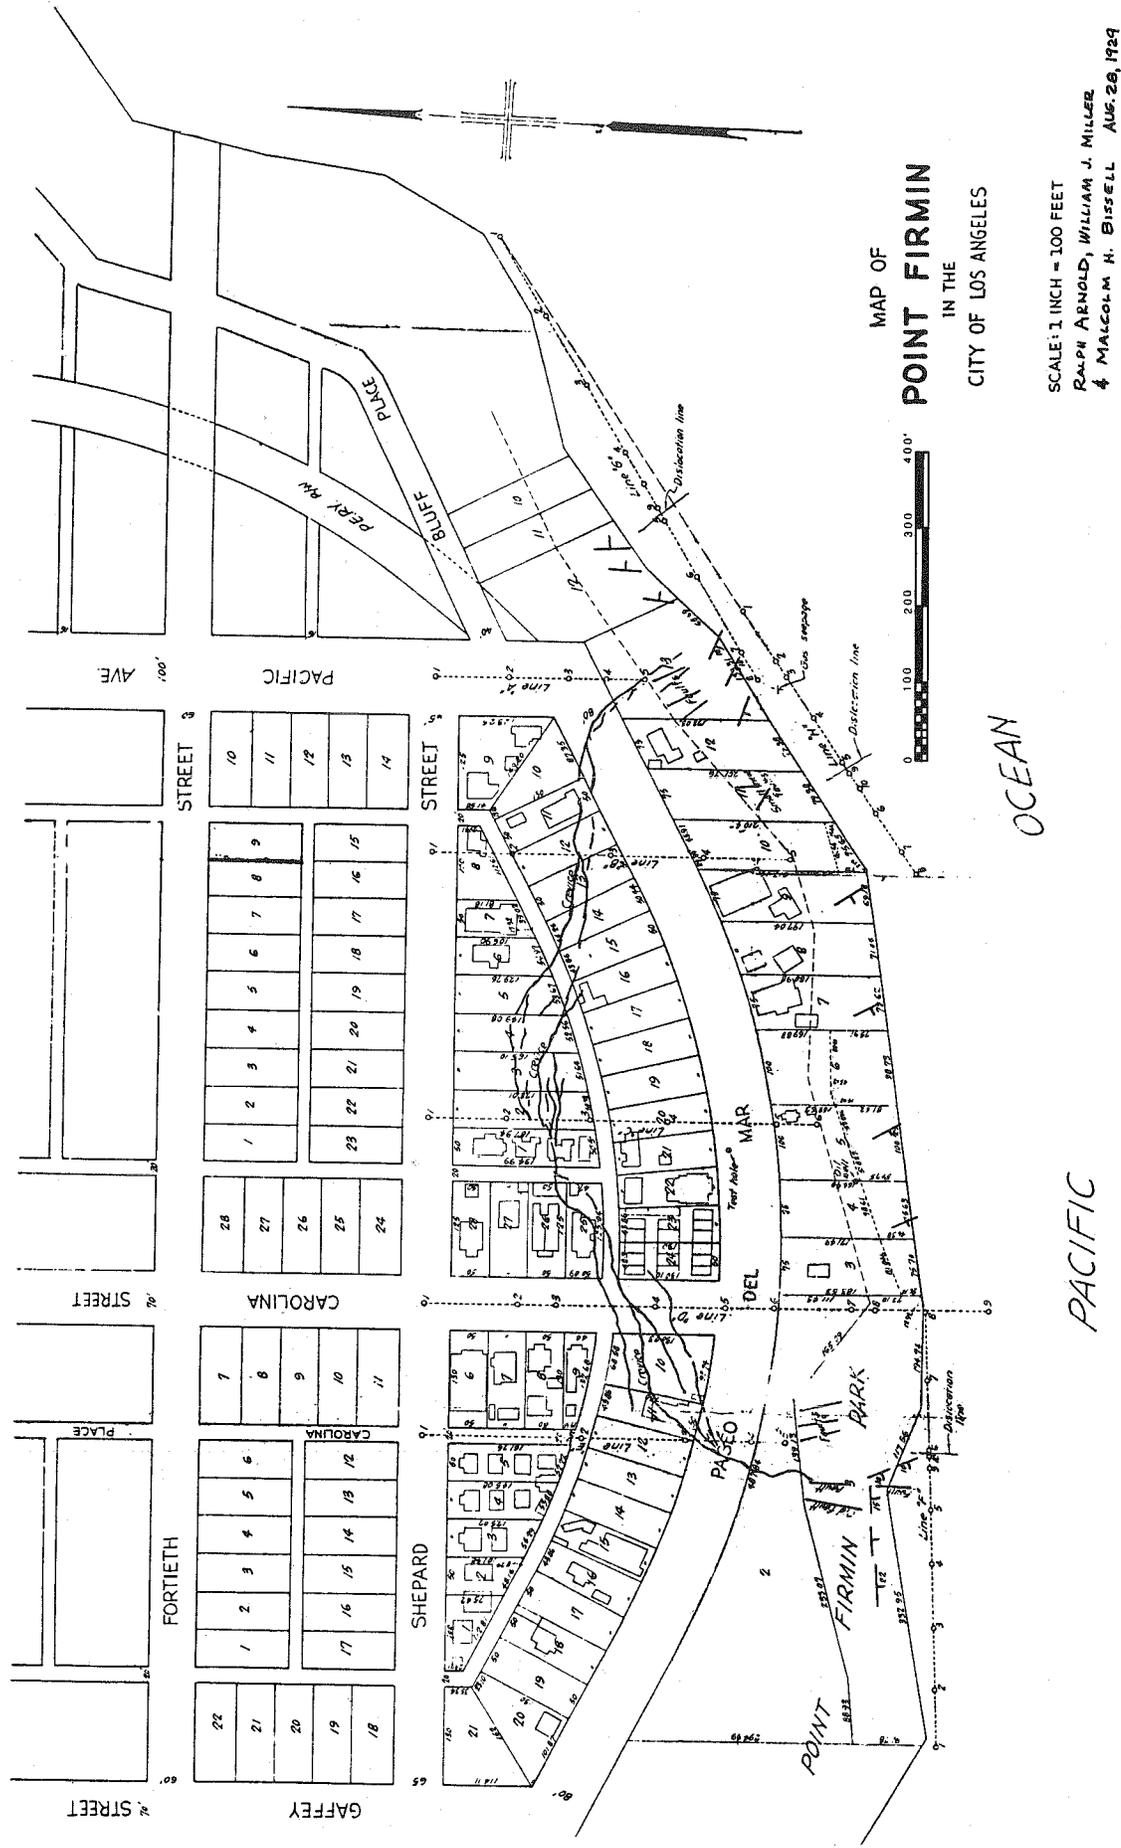
FIGURE 1: Point Fermin landslide as mapped by Arnold and others in 1929. (Note error in spelling of name).

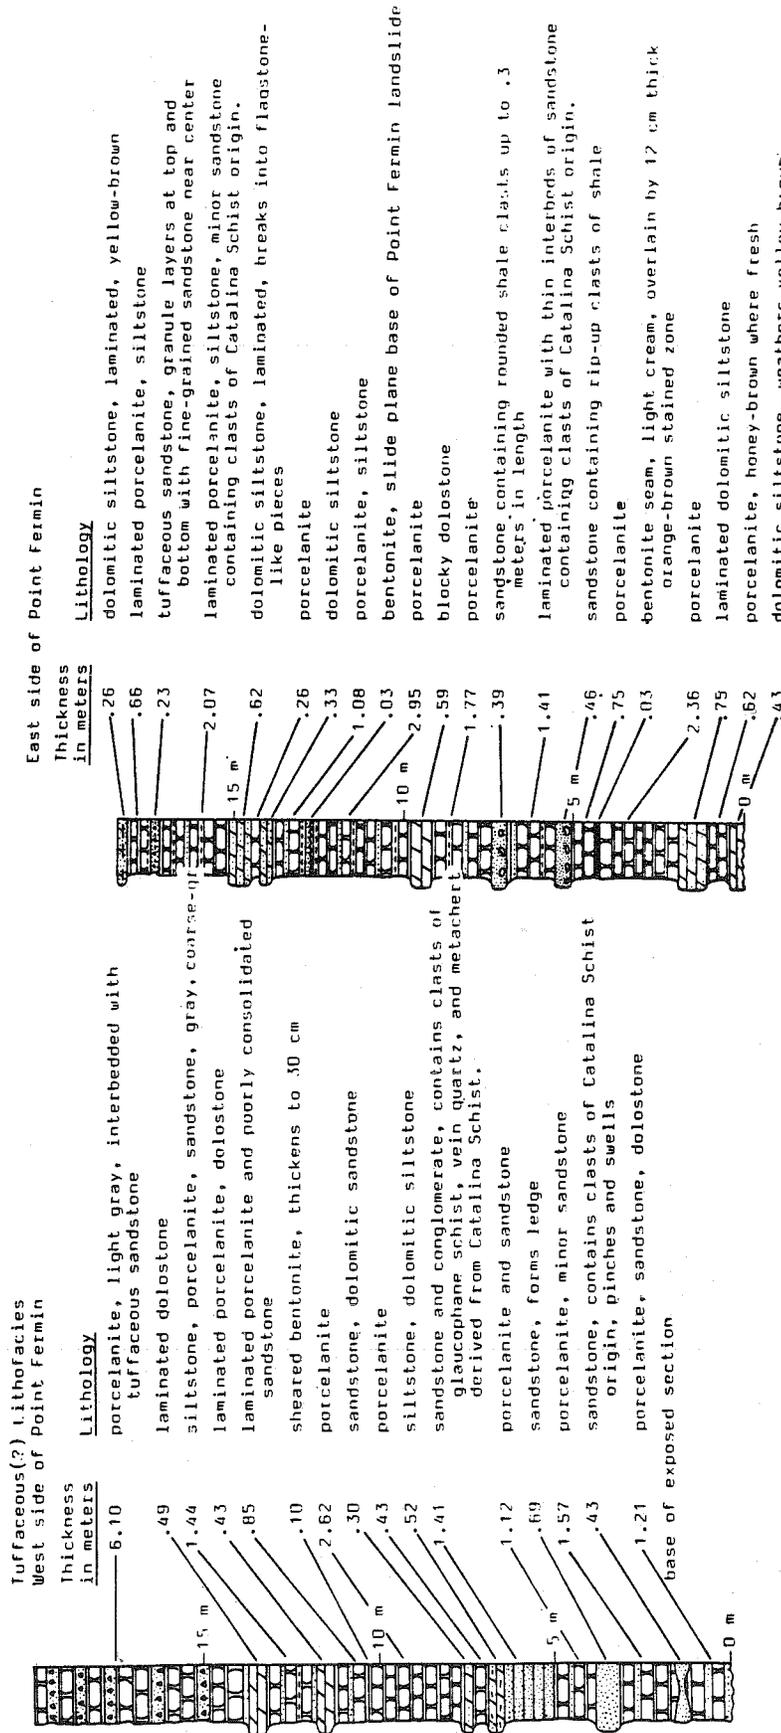
FIGURE 4: Lithofacies of the west and east sides of Point Fermin (Conrad, in Scullin, 1986). Compare boring logs B-1 and B-2 (Figure 7) with "east side" lithofacies.

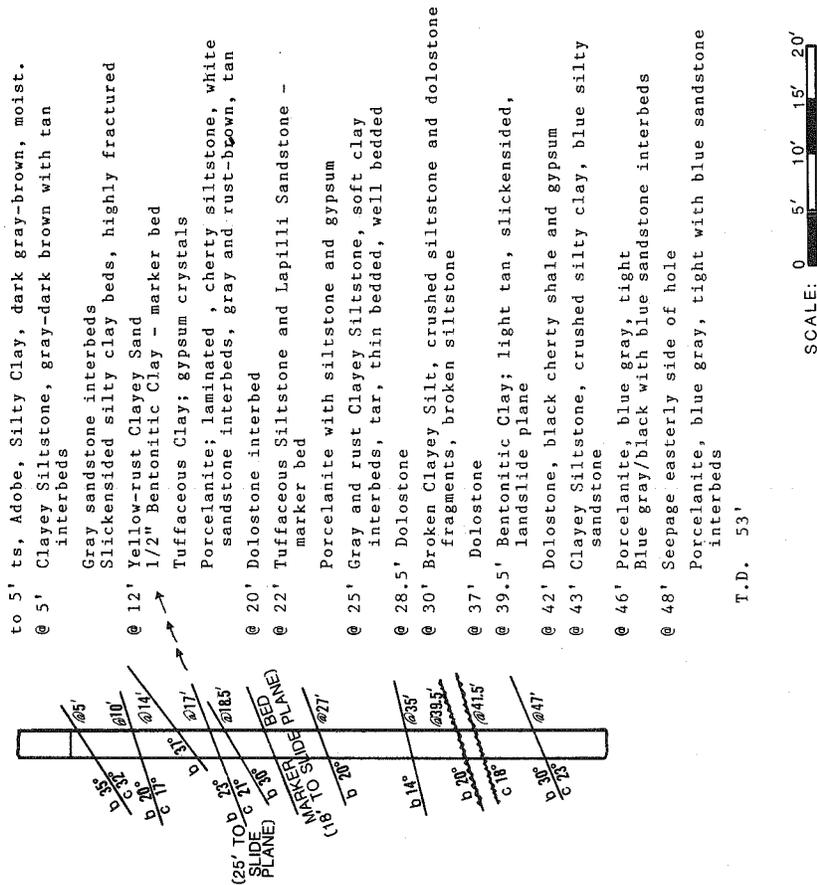
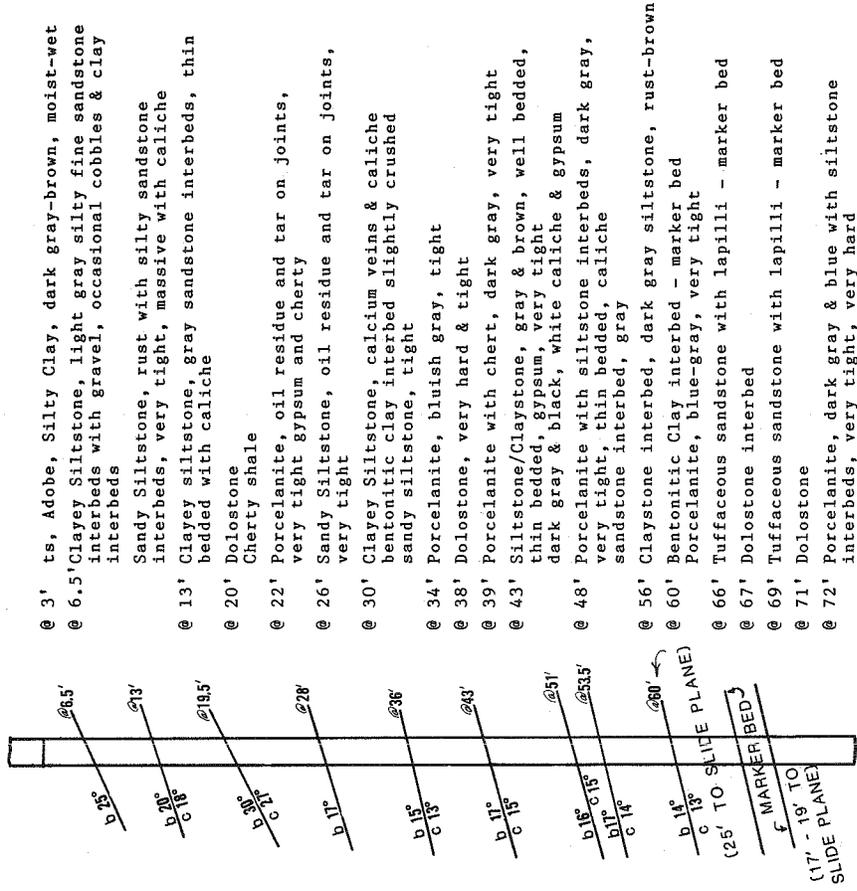
Boring B-1 was located on a pad area near the head-scarp slope. It was drilled to 53 feet depth and penetrated the landslide plane at 39.5 feet to 41.5 feet depth. Boring B-2 was located in the City of Los Angeles Department of Recreation and Parks property directly south of the subject site and Boring B-1. It is adjacent to the active eastern landsliding. Boring B-2 was terminated at 77 feet depth due to hard drilling. It did not penetrate the slide plane; however, it did extend through the tuffaceous sandstone with lapilli marker bed that is 17 feet to 19 feet above the bentonitic clay slide plane. The lithology of the stratigraphic section is similar in Borings B-1 and B-2 and also to the landslide blocks exposed in the bluffs southerly of Pacific Avenue. A copy of the lithology described by Cathy L. Conrad, Department of Geology, California State University Los Angeles, California 90032, is attached (Figure 4) for comparison with the stratigraphic units described on our Cross-Section A-A' (Figure 8) and our drilling logs (Figures 7A and 7B). Based upon the correlation of the above, we assume that the landslide plane is at 85 feet to 87 feet depth at the Boring B-2 location. Another marker bed is a 1/2 inch to 1 foot bentonitic clay interbed located 25 feet to 26.5 feet above the slide plane. These marker beds, particularly the tuffaceous sandstone with lapilli are well exposed in the sea bluff above the slide plane and above the beach at the toe of the slide. The slide plane beneath the subject property varies from 10 feet  $\pm$  depth at the front property line to approximately 50 feet  $\pm$  depth at the rear property line. There is approximately 380 feet  $\pm$  length of landslide mass, 75 feet to 80 feet  $\pm$  thick between the rear property line of Lots 3 and 4 and the ocean. The slide plane extends up toward Shepard Street at a 20° angle and would daylight near the center line of the street if it surfaced at that angle.

FIGURE 7: Geologic logs of borings from the Point Fermin landslide. Locations of borings B-1 and B-2 are shown on geologic map (Figure 6) and section (Figure 8).

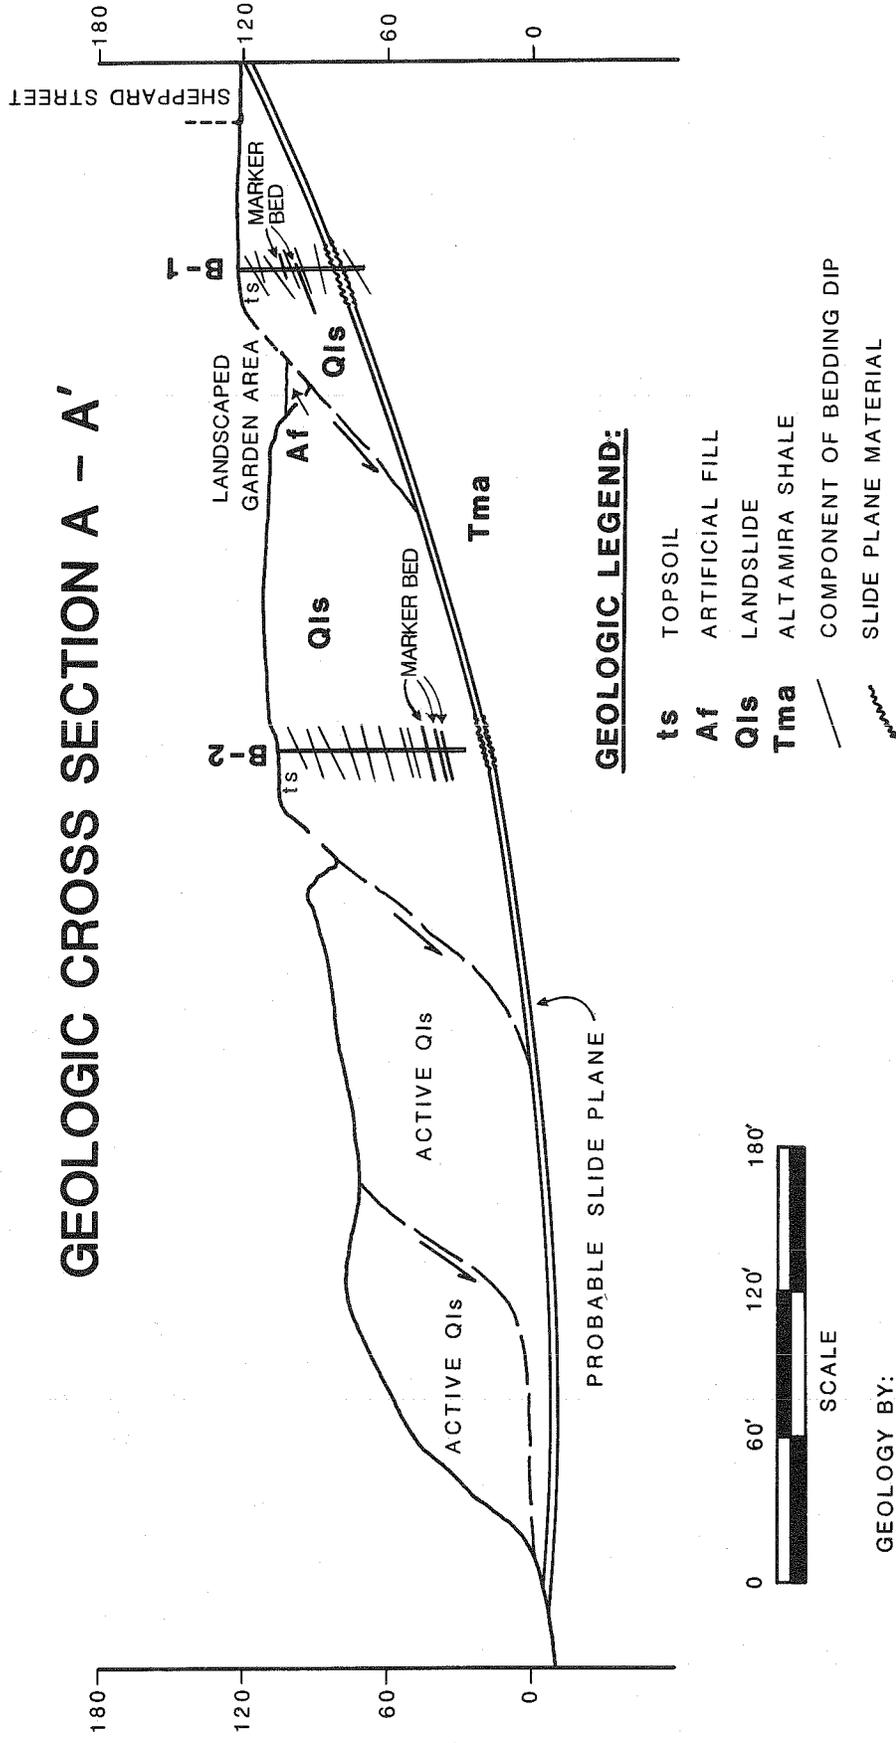
# GEOLOGIC CROSS SECTION A - A'

FIGURE 8: Geologic cross section A-A' of Point Fermin landslide. Location of section is shown on map (Figure 6).
