Engineering Geologic Evaluation Sunken City / Point Fermin Landslide

Potential Ground Failure Safety Issues Associated with Public
Use of the Landslide Area

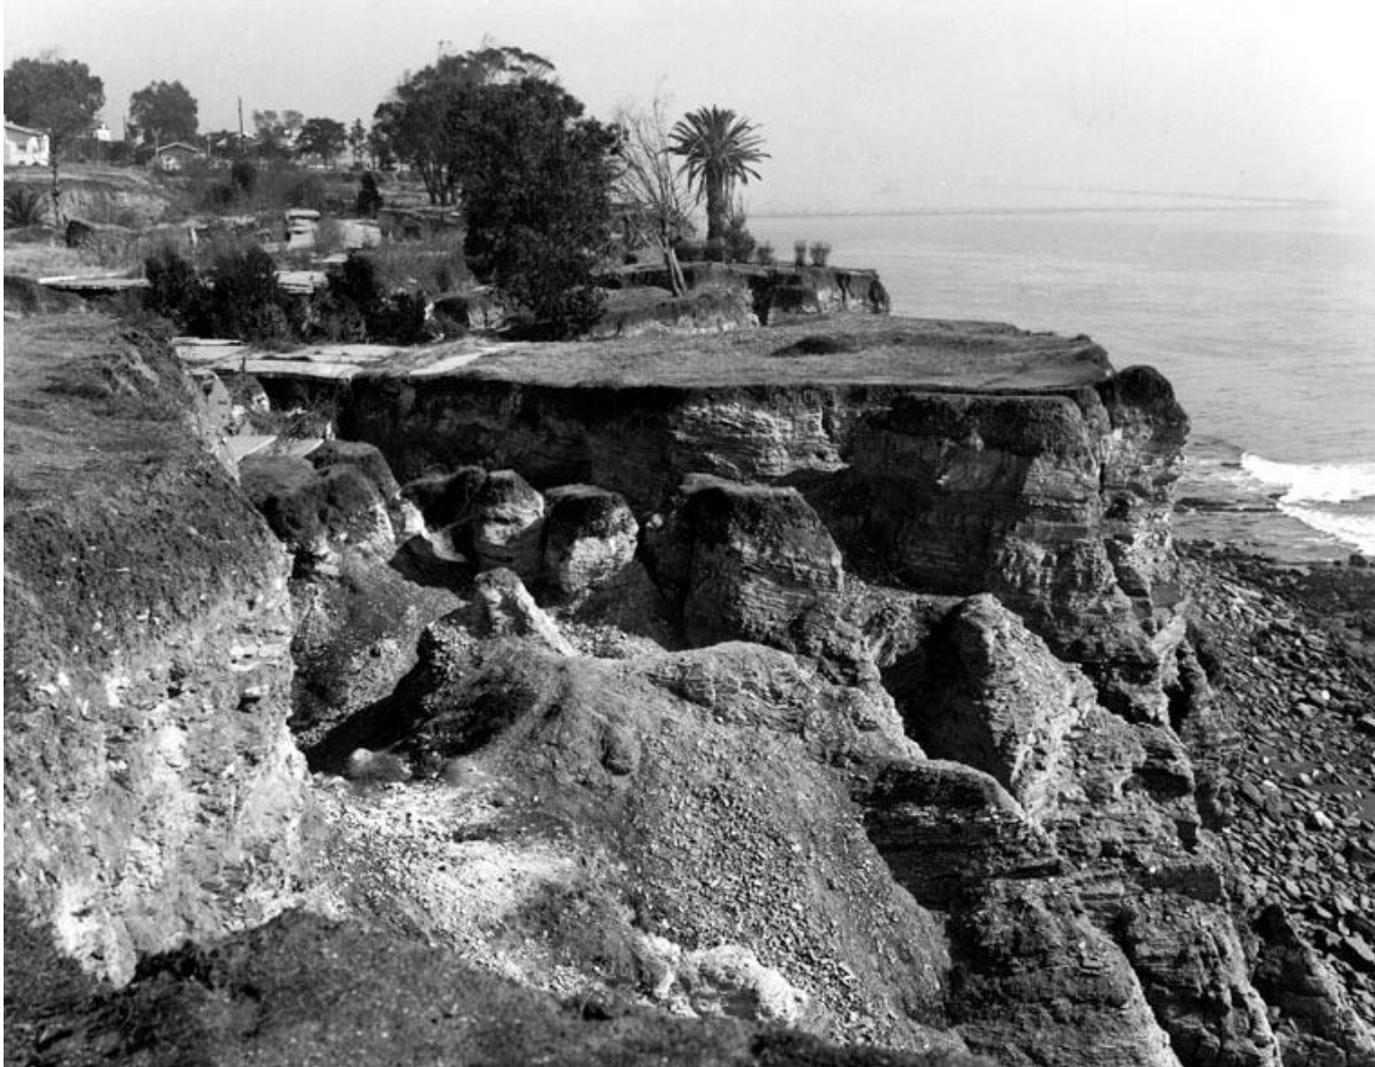
Circa 1942 - Sunken City Landslide Area

- ▶ The 1940-41 rainfall year was the wettest on record at that time (i.e., since 1883-84), with an annual total of approximately 33 inches of rain;
 - ▶ A dissipating hurricane reportedly made landfall in southern California in September 1939; high surf conditions out of the South were recorded, including large waves that destroyed the outer 300 feet of the Huntington Beach Pier; the subject area faces directly South;
 - ▶ The combined effects of high rainfall/groundwater conditions and coastal erosion along the toe of the slide mass apparently precipitated acceleration of the slide movement and formation of the Sunken City portion of the landslide.
-

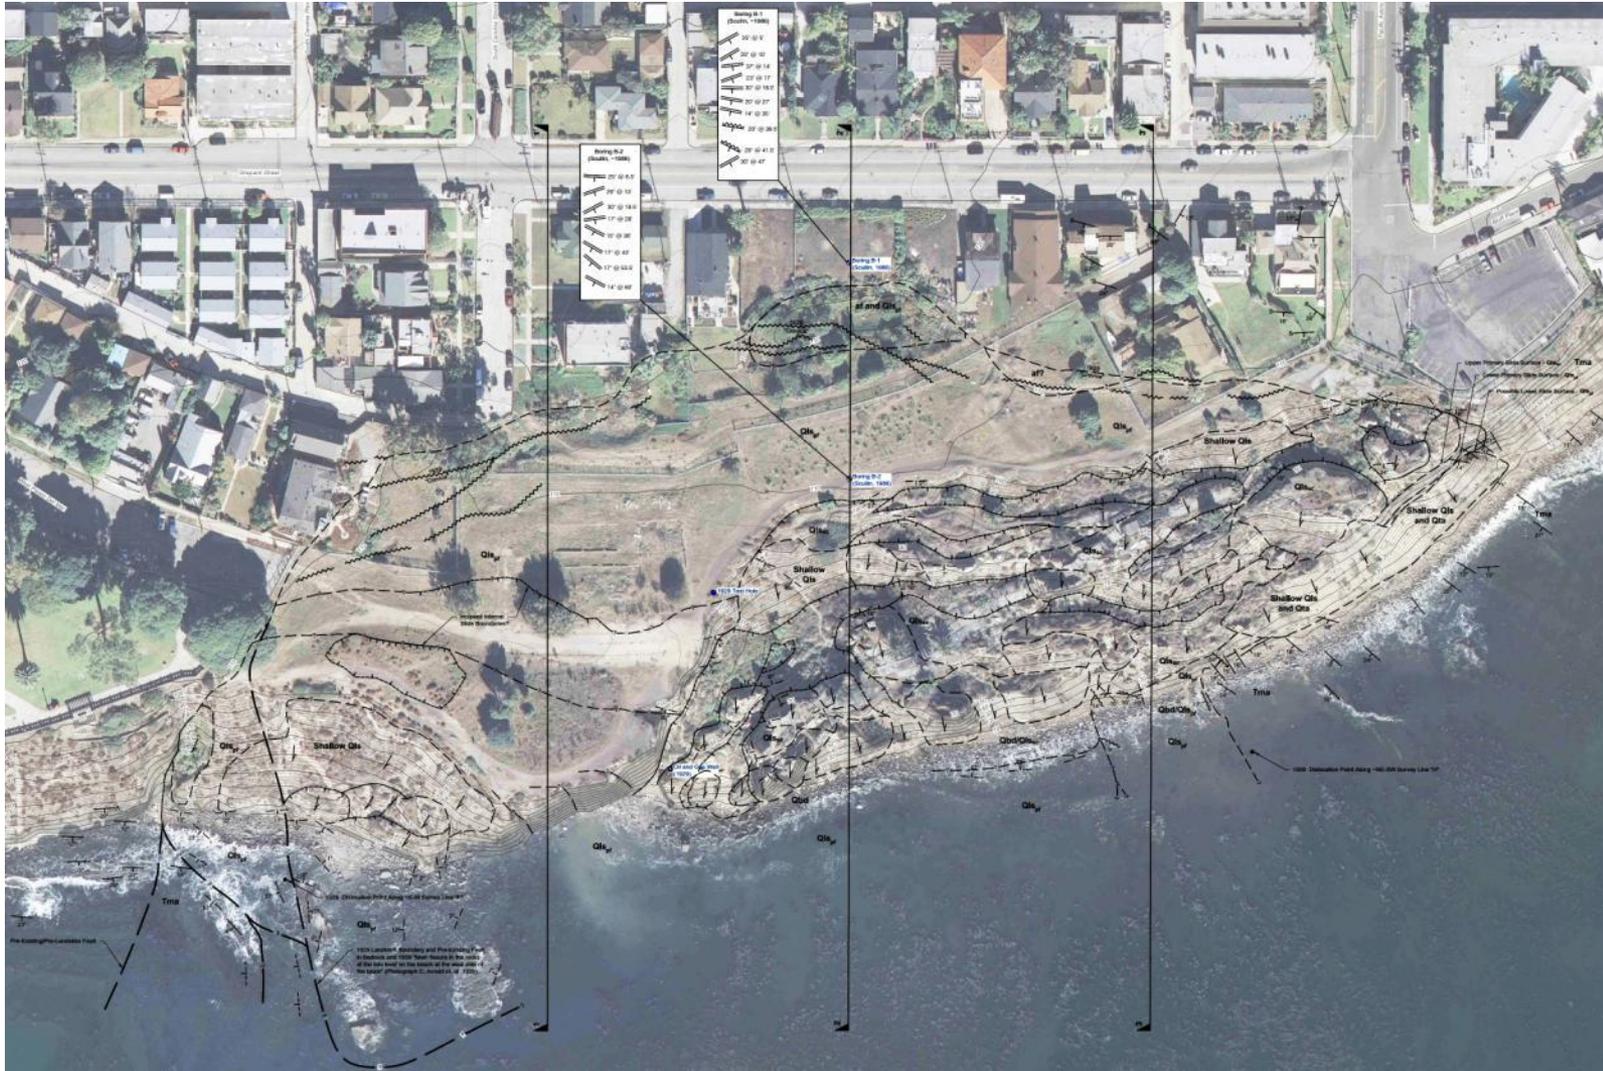
2016 Geologic Map Amec Foster Wheeler

- ▶ Displacement of the Pt. Fermin landslide originally occurred as a relatively coherent block or rock mass that moved seaward along weak strata/bedding in the underlying bedrock that are tilted towards the ocean (this is known as a translational or block glide landslide);
 - ▶ The seaward tilt of the bedrock strata and the presence of weak bentonite clay beds are the physical properties that control the location and extent of the landsliding;
 - ▶ These conditions can be likened to an old deck of sticky playing cards with some slippery new cards at the bottom of the deck – when the deck of cards is tilted slightly the block of sticky cards slides down the inclination of the slippery new cards near the base;
 - ▶ Bentonite clay beds form the base of both the larger, deeper Point Fermin Landslide and the smaller, shallower Sunken City landslide.
-

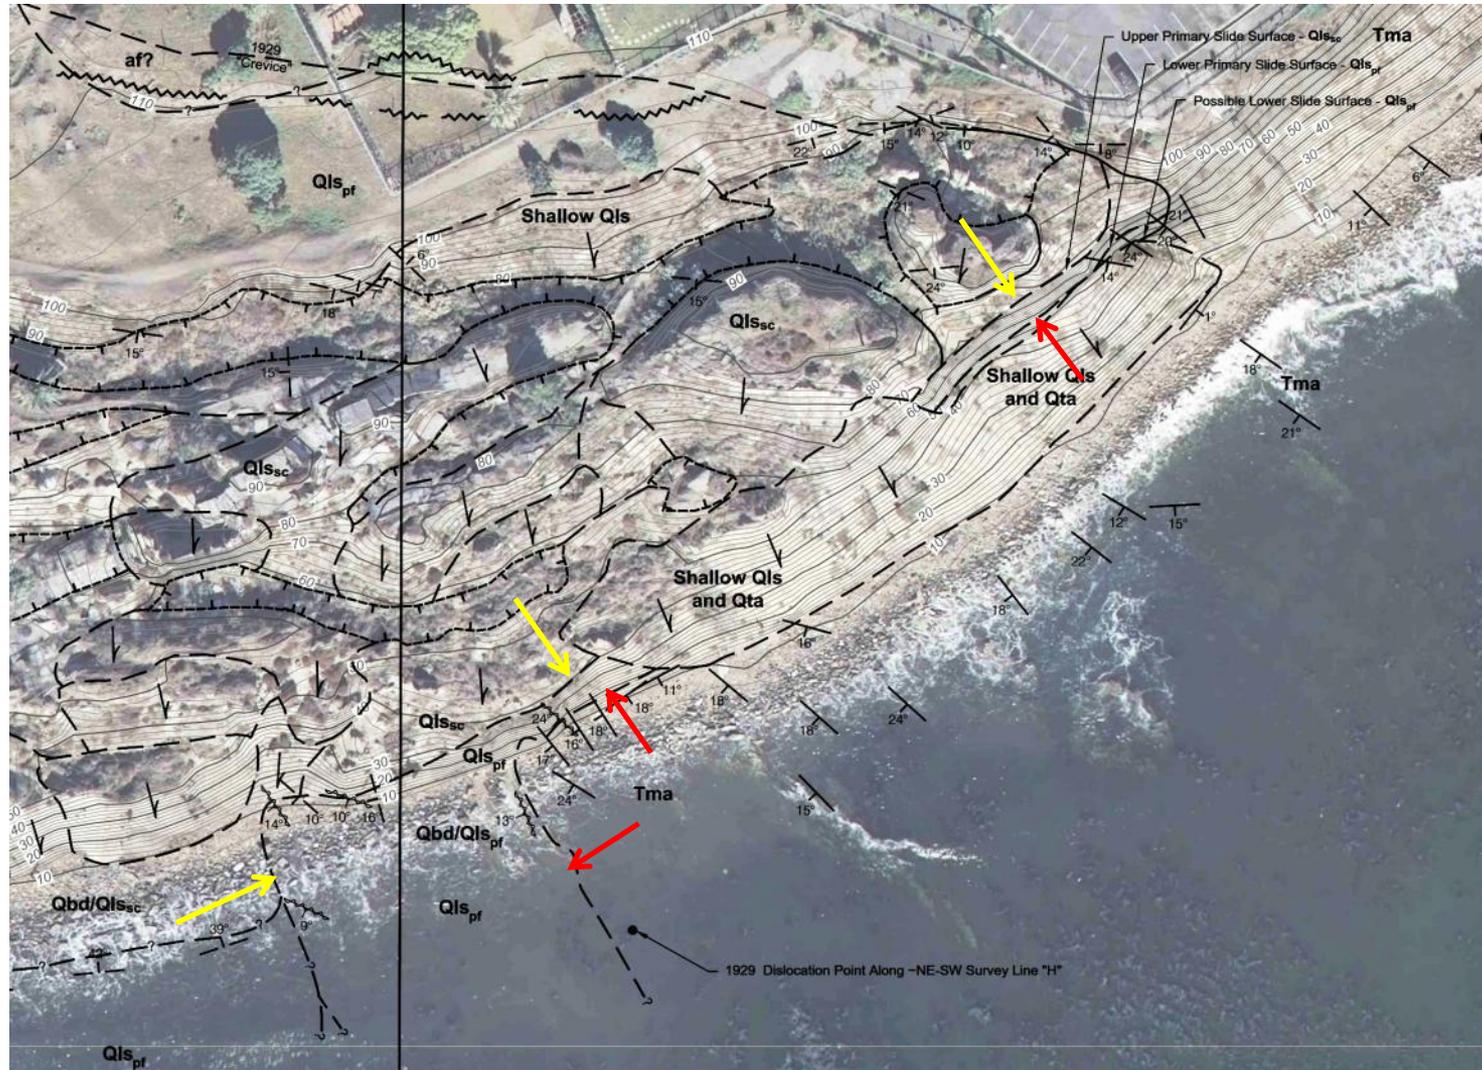
2016 Geologic Map Excerpt Showing the Exposed Base of Sunken City and Point Fermin Landslides

Exposed Base of Pont Fermin Landslide (red arrows) and Sunken City Landslide (yellow arrows)
